**ZONE 7 WATER AGENCY**  
100 North Canyons Parkway  
Livermore, CA

**Figure 3.2-1**  
**Zone 7 Groundwater Program**  
**Wells in 2011 Program**  
**Livermore Valley Groundwater Basin**

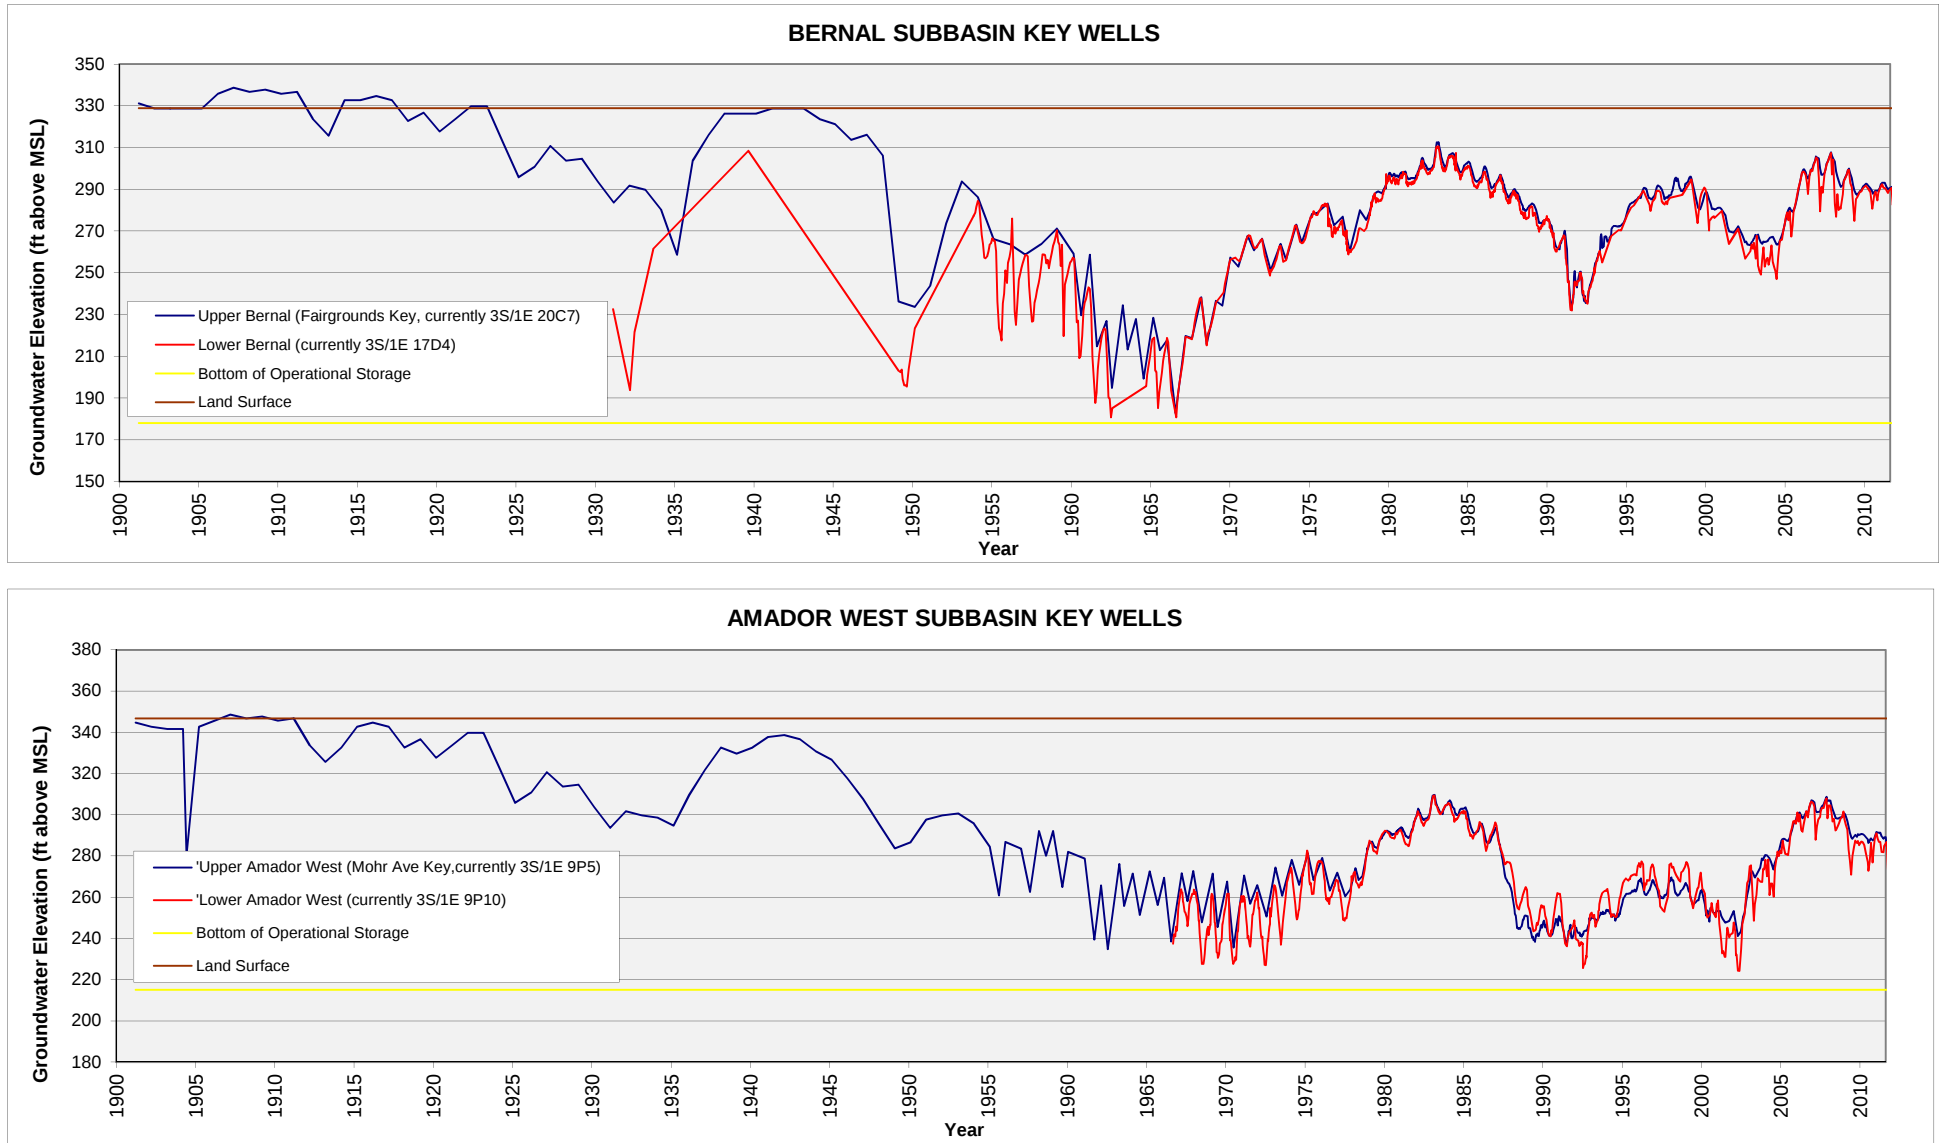
**FIGURE 3.2-2  
ZONE 7 WATER AGENCY  
Key Well Hydrographs - Historical  
Western Portion of Main Basin**

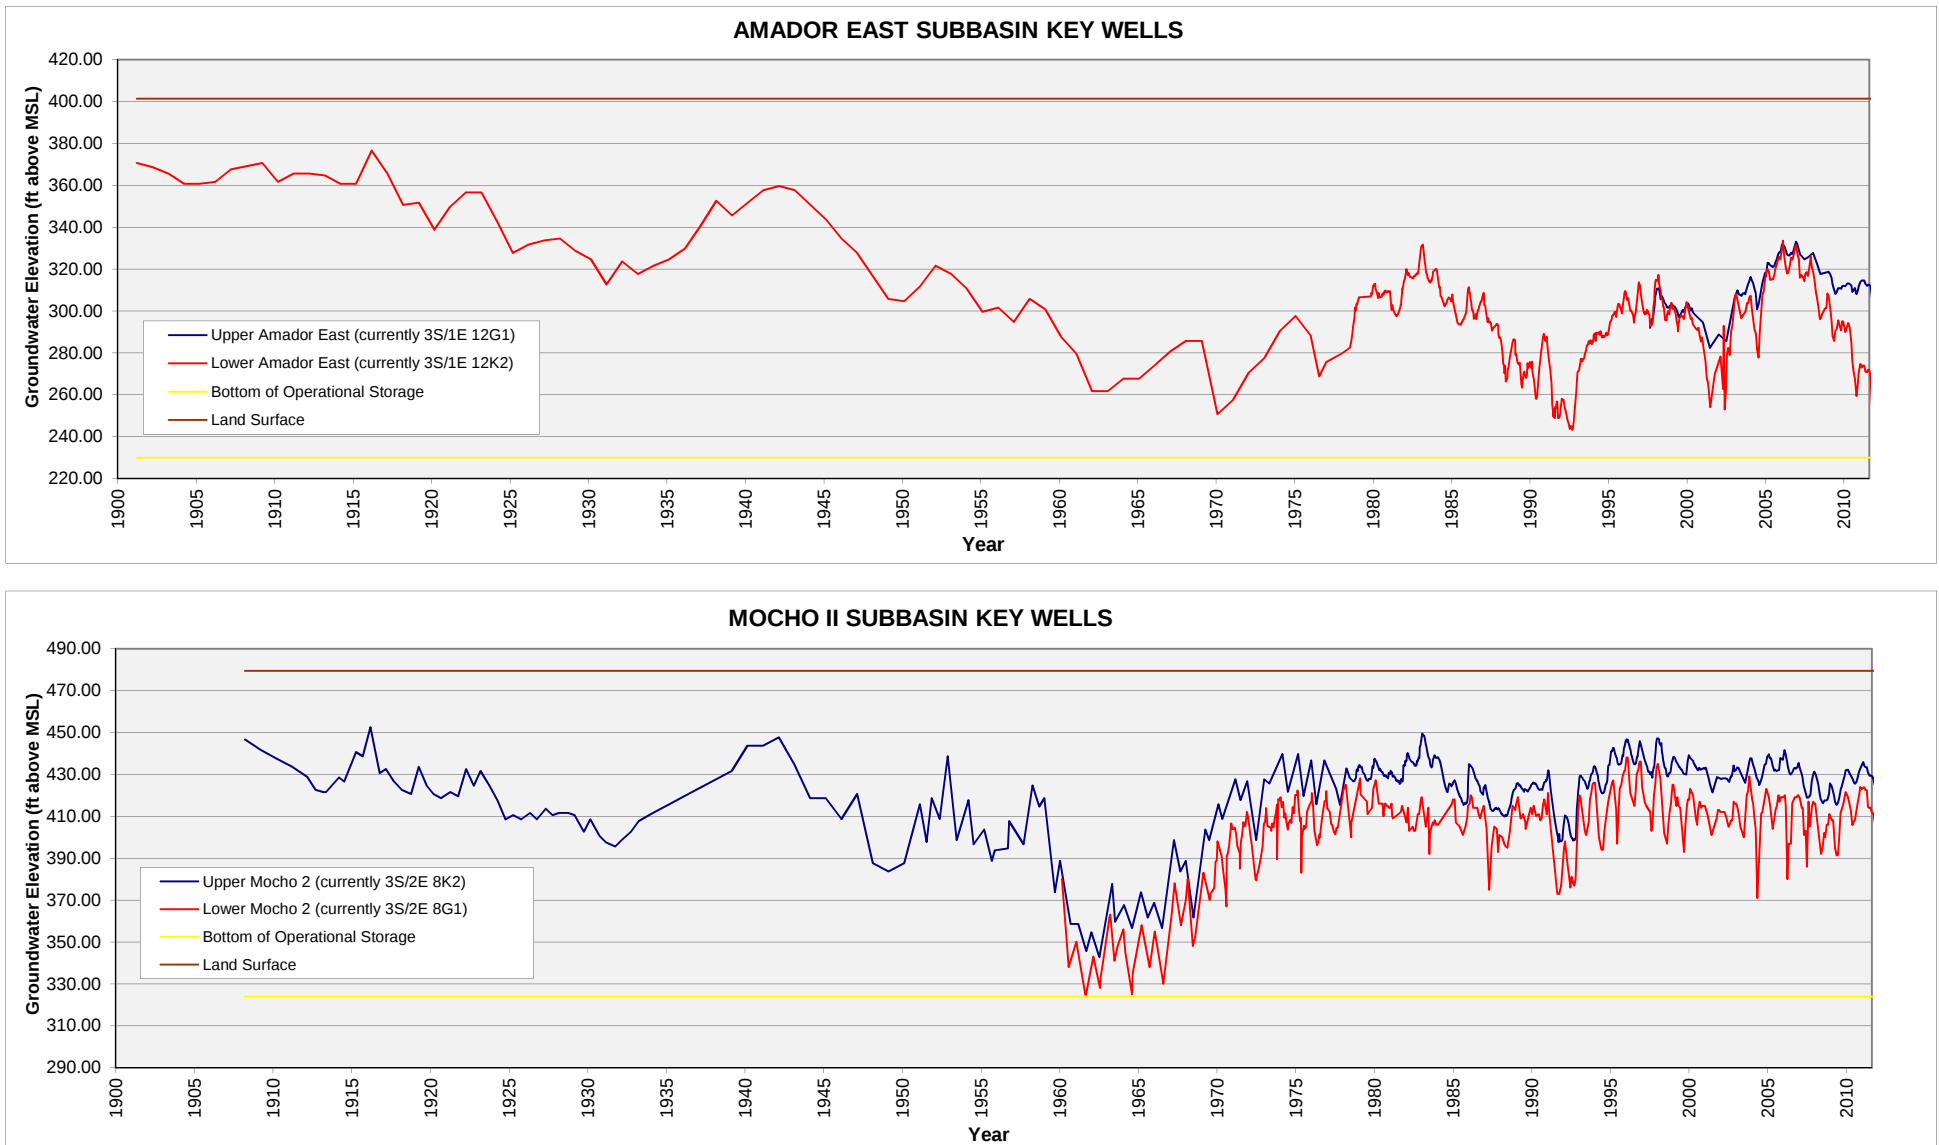
**FIGURE 3.2-2  
ZONE 7 WATER AGENCY  
Key Well Hydrographs - Historical  
Eastern Portion of Main Basin**

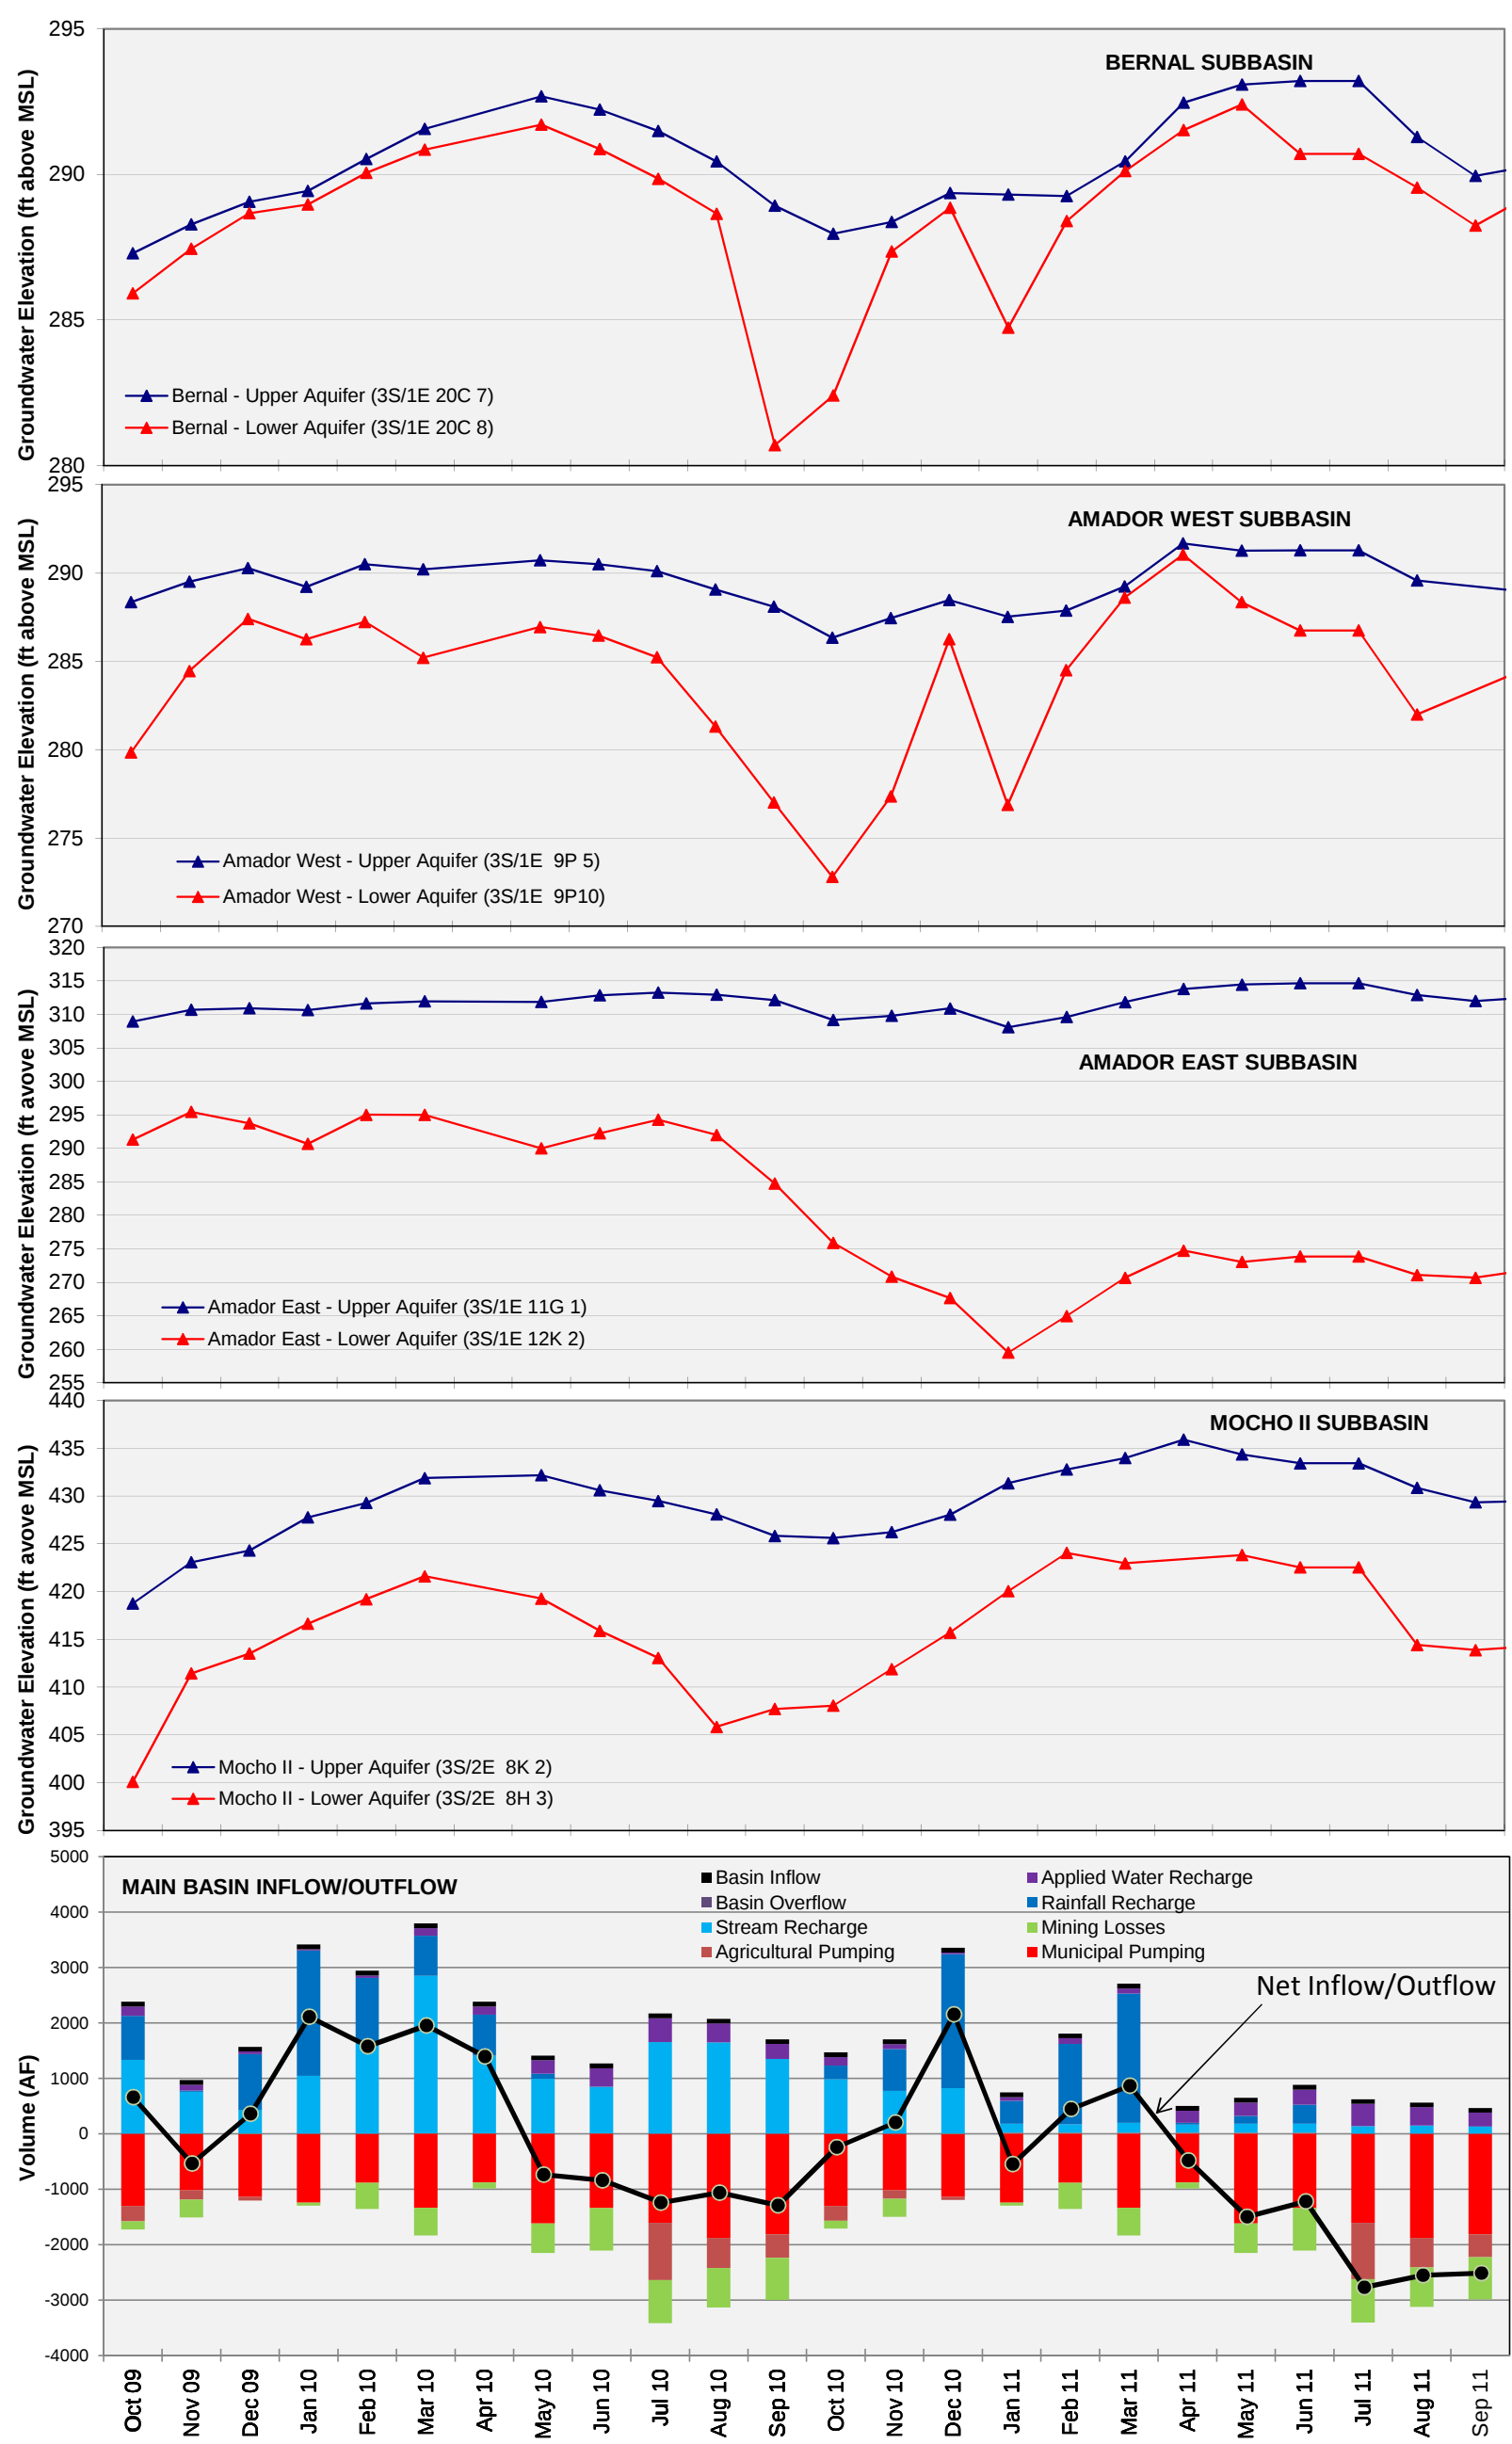
FIGURE 3.2-3  
ZONE 7 WATER AGENCY  
Key Well Hydrographs  
2010 to 2011 Water Years

Notes: No water levels taken in April 2010

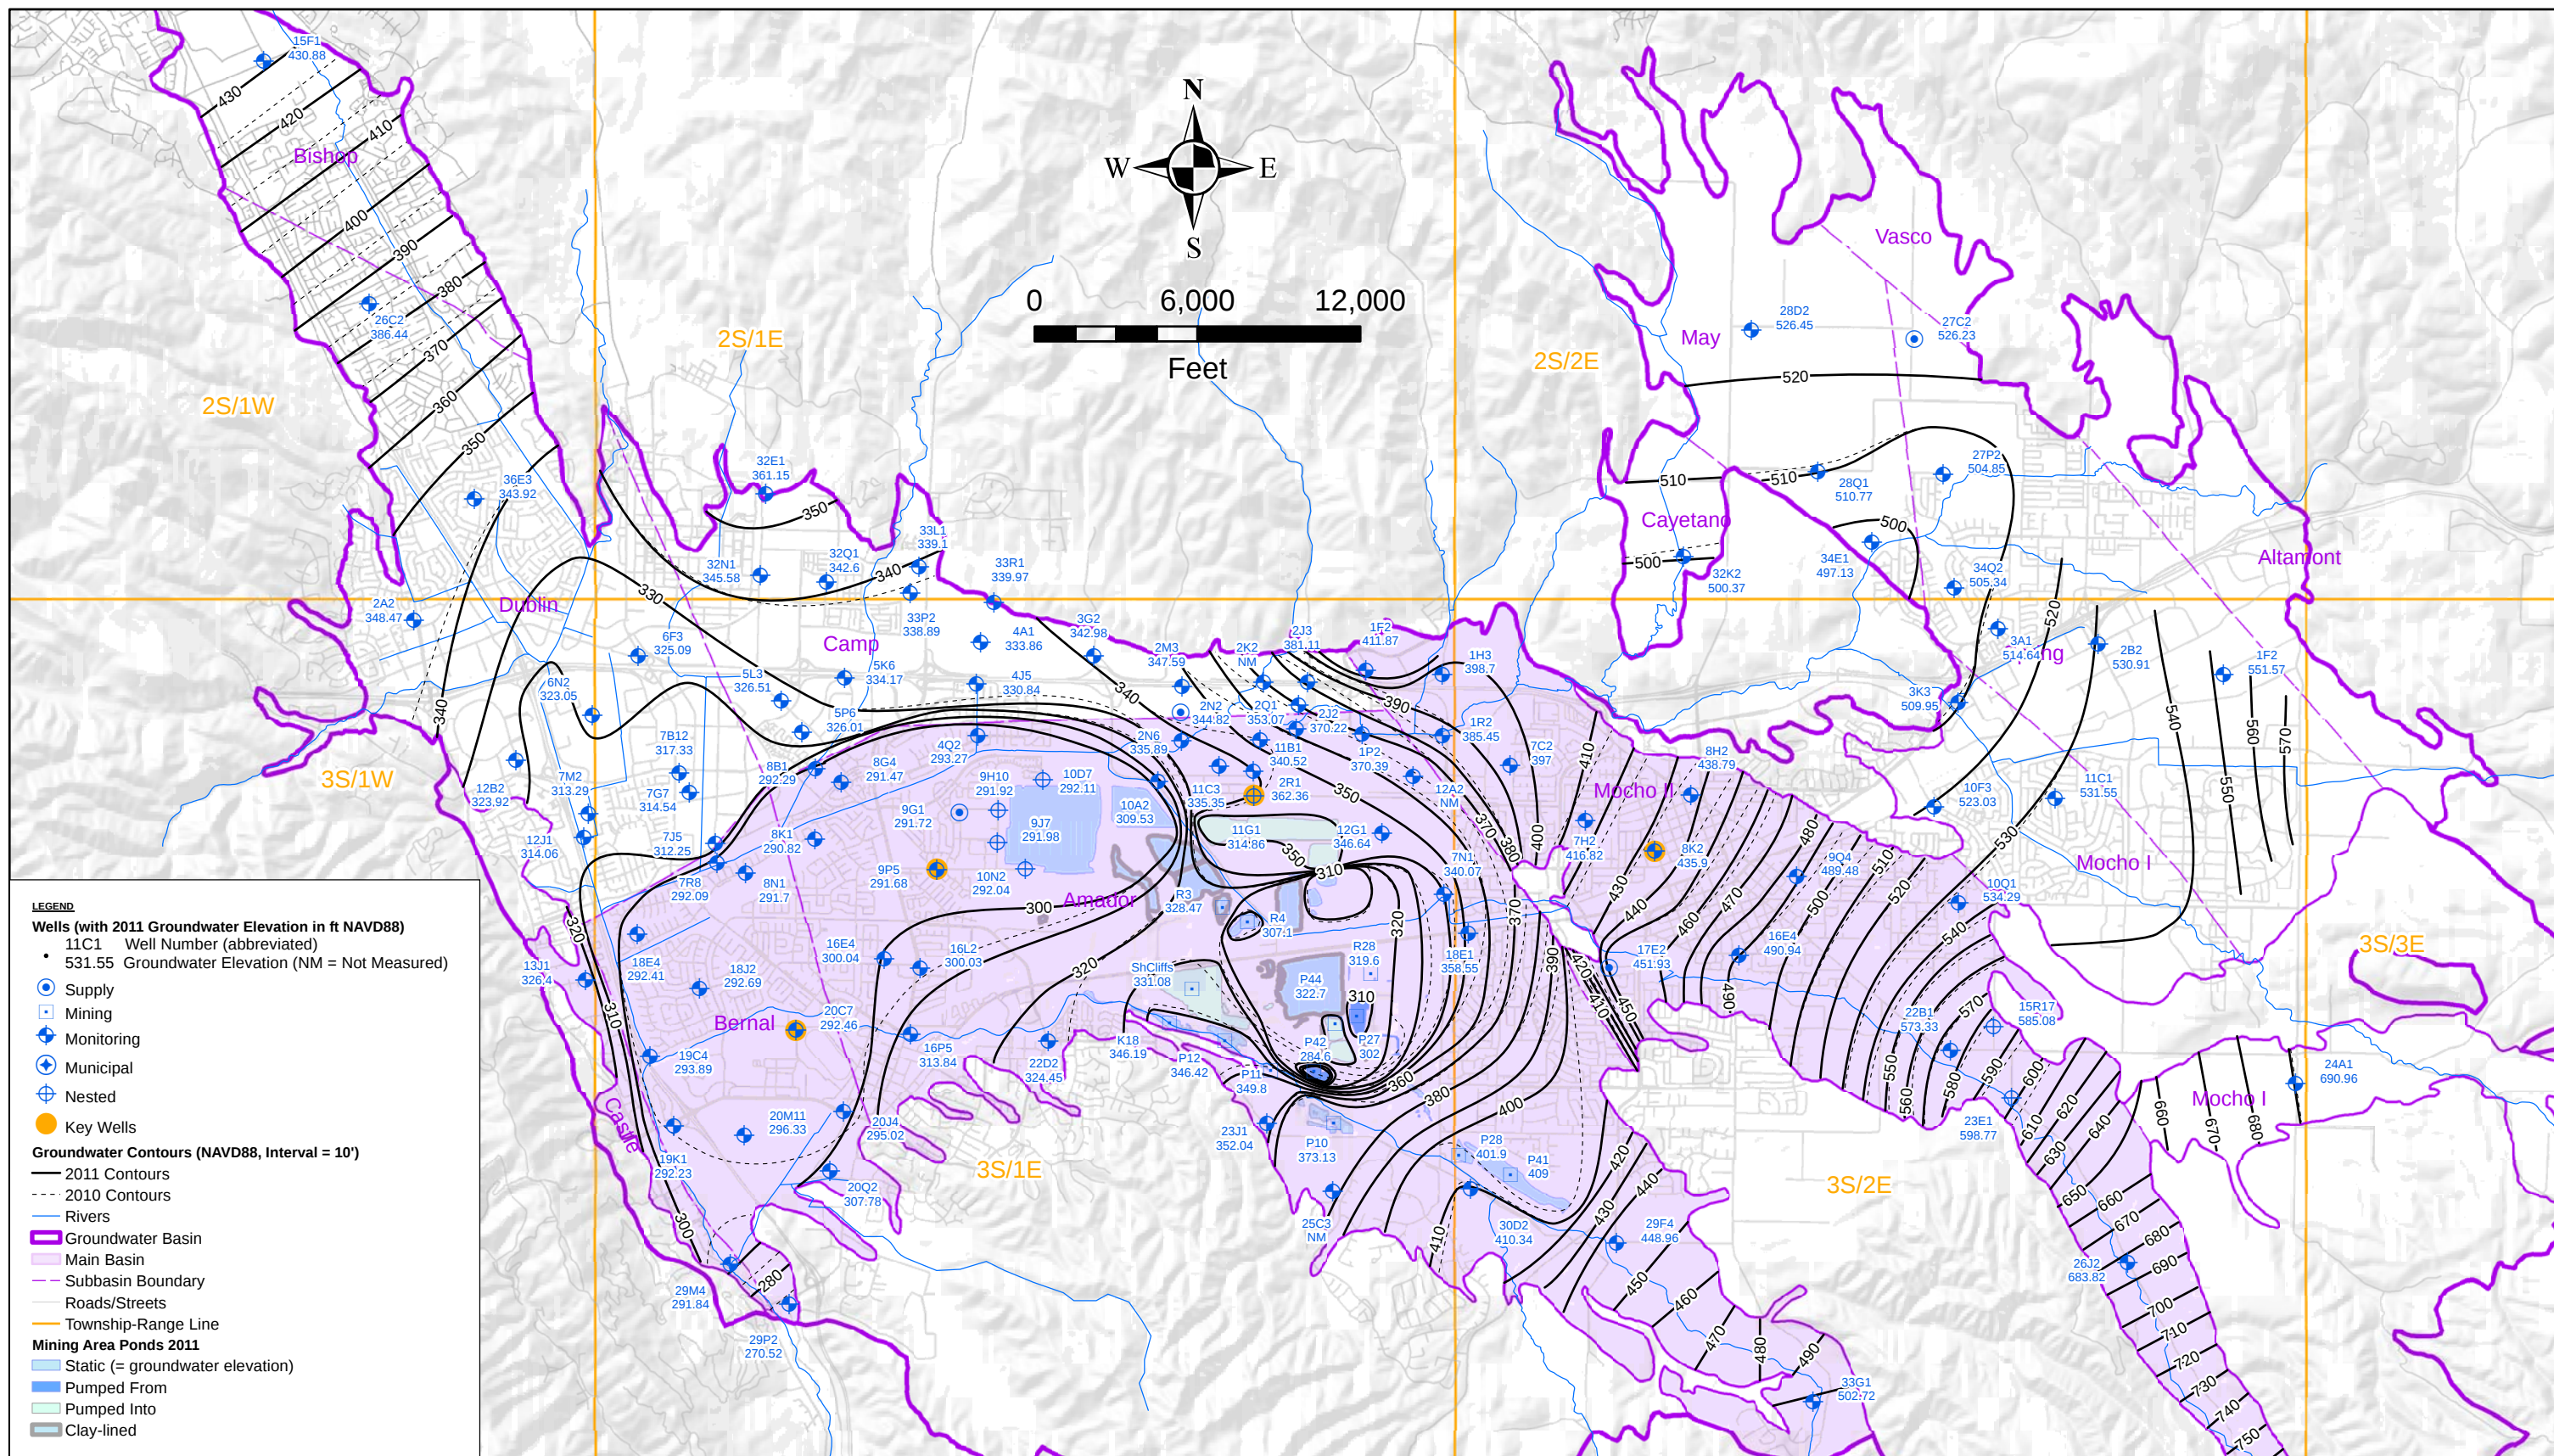
**Figure 3.2-4**  
**Groundwater Gradient Map**  
**Upper Aquifer; Spring 2011 (April)**  
**Livermore Valley Groundwater Basin**

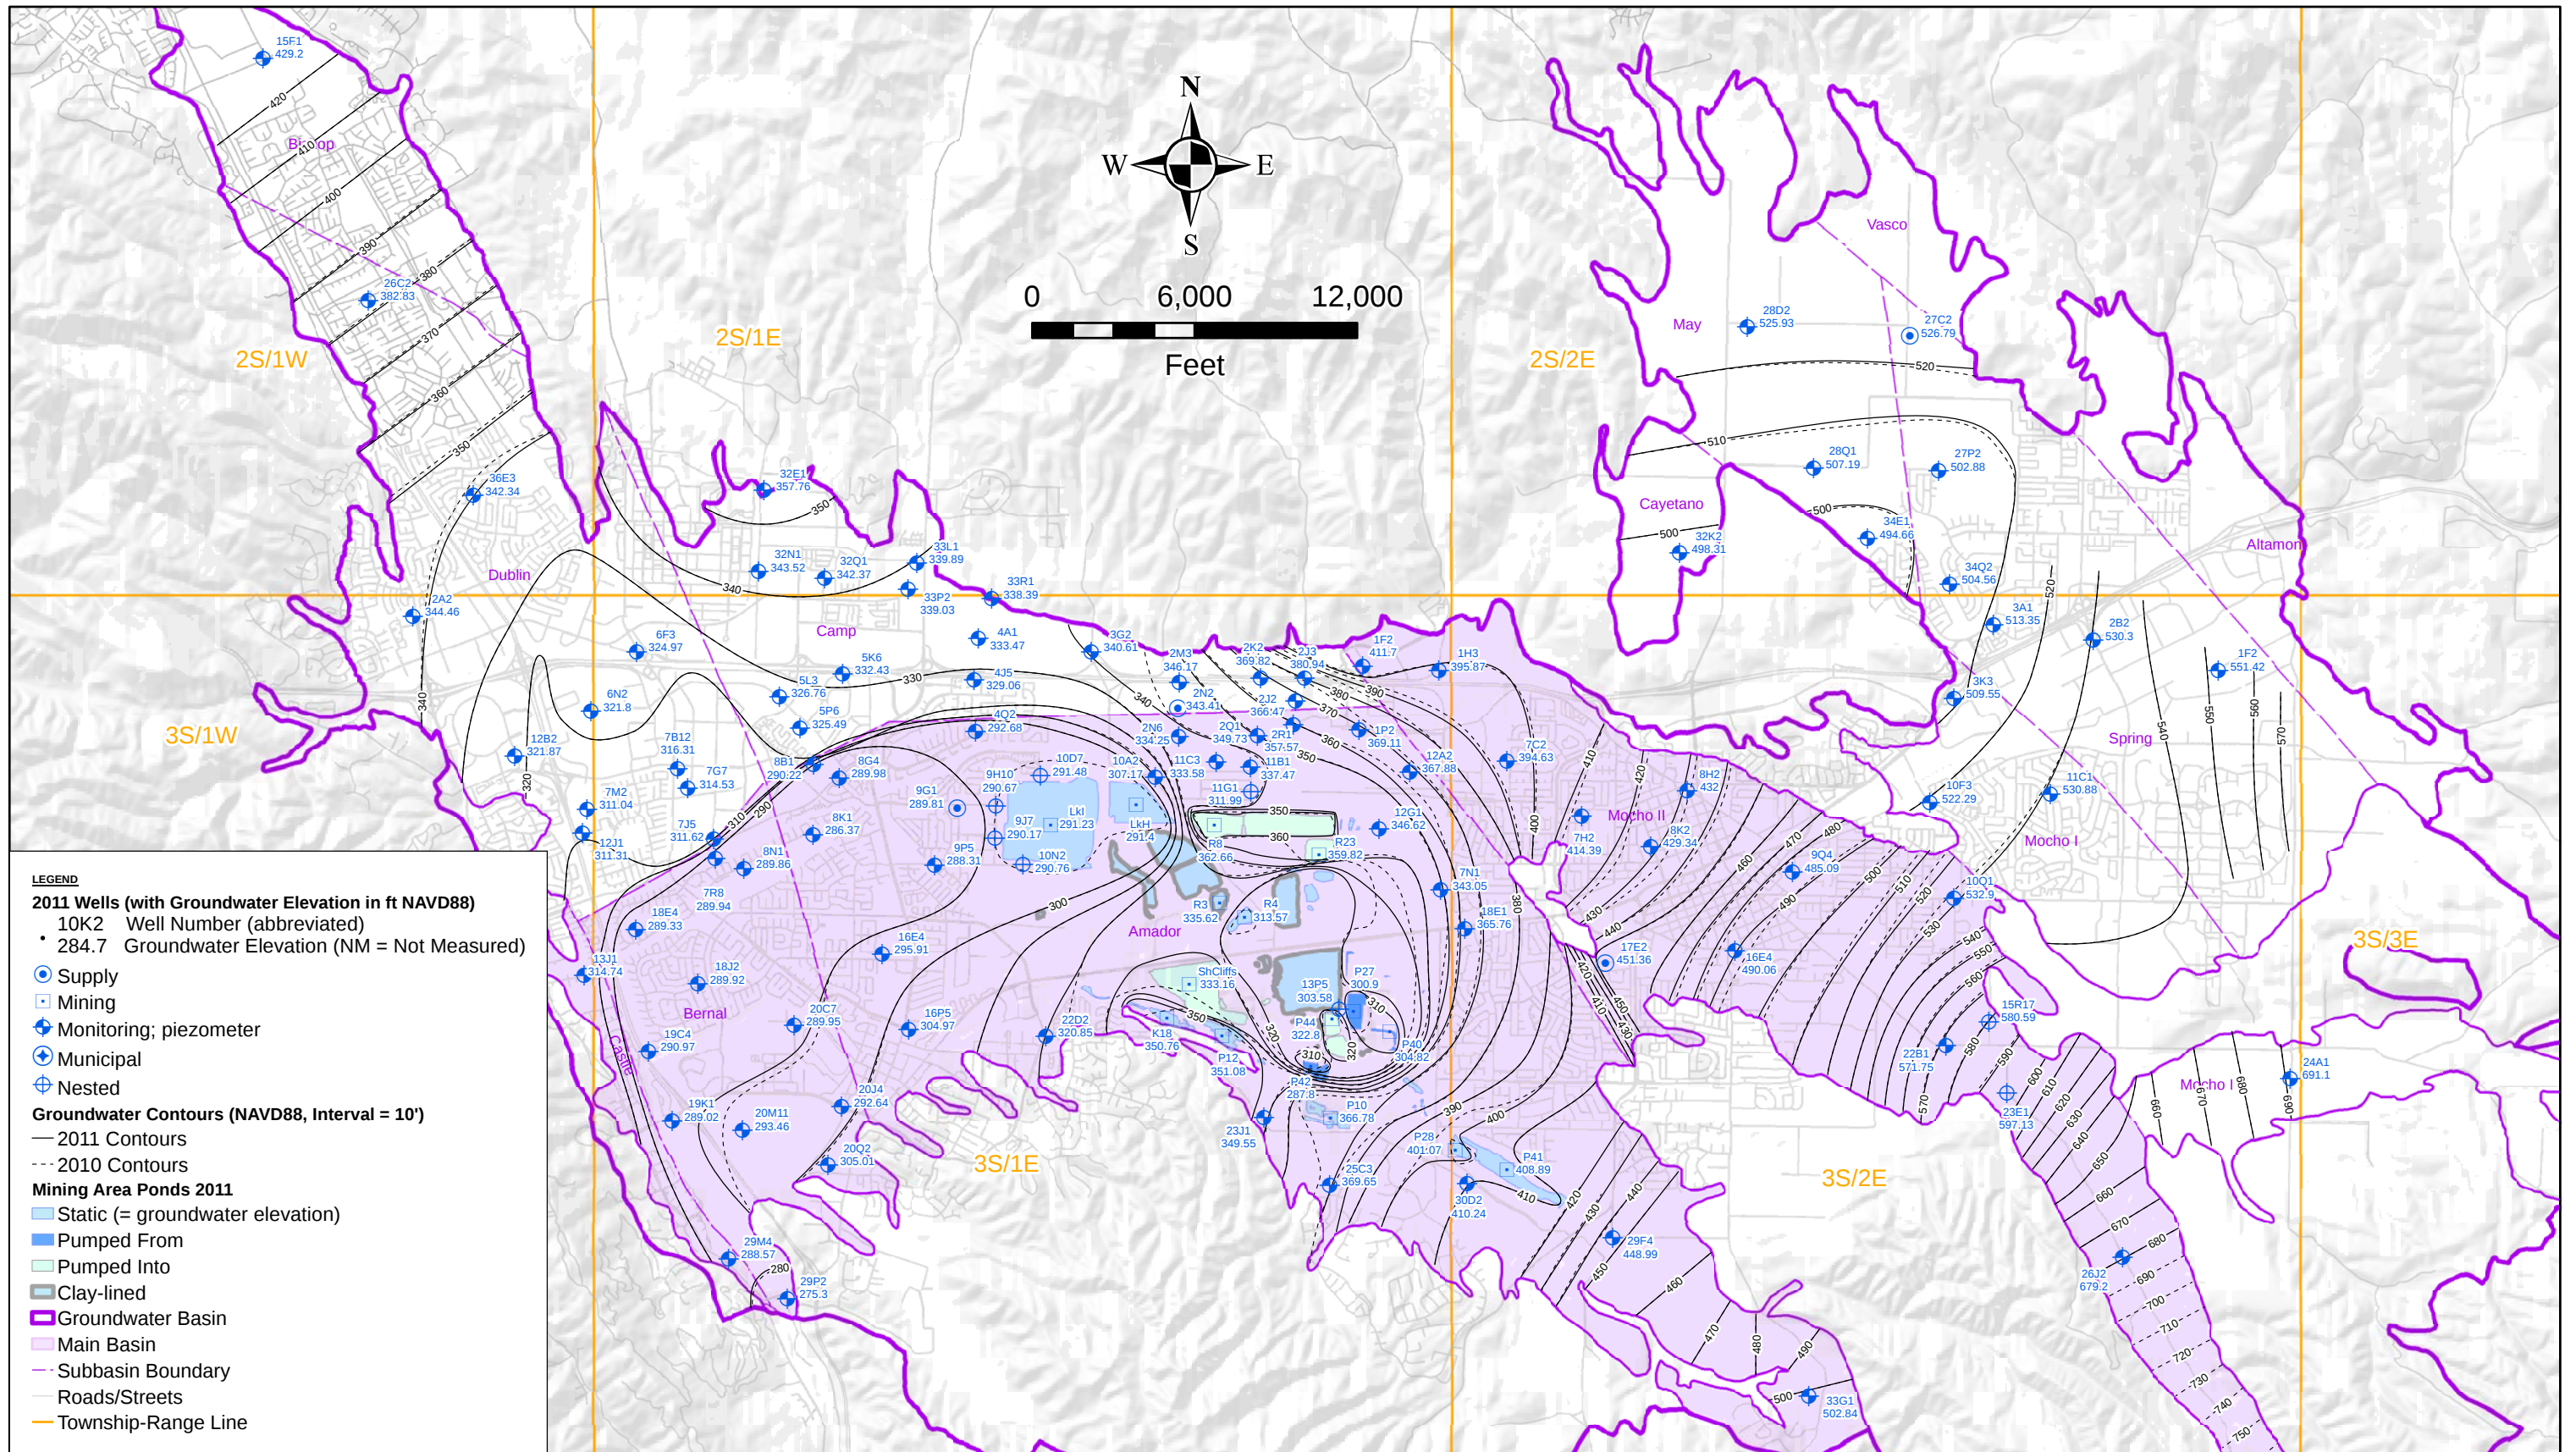
**Figure 3.2-5**  
**Groundwater Gradient Map**  
**Upper Aquifer; Fall 2011 (September)**  
**Livermore Valley Groundwater Basin**
