**ZONE 7 WATER AGENCY**  
100 North Canyons Parkway  
Livermore, CA

**Figure 3.2-9**  
**TDS Concentrations (mg/L)**  
**Upper Aquifer; 2011 Water Year**  
**Livermore Valley Groundwater Basin**

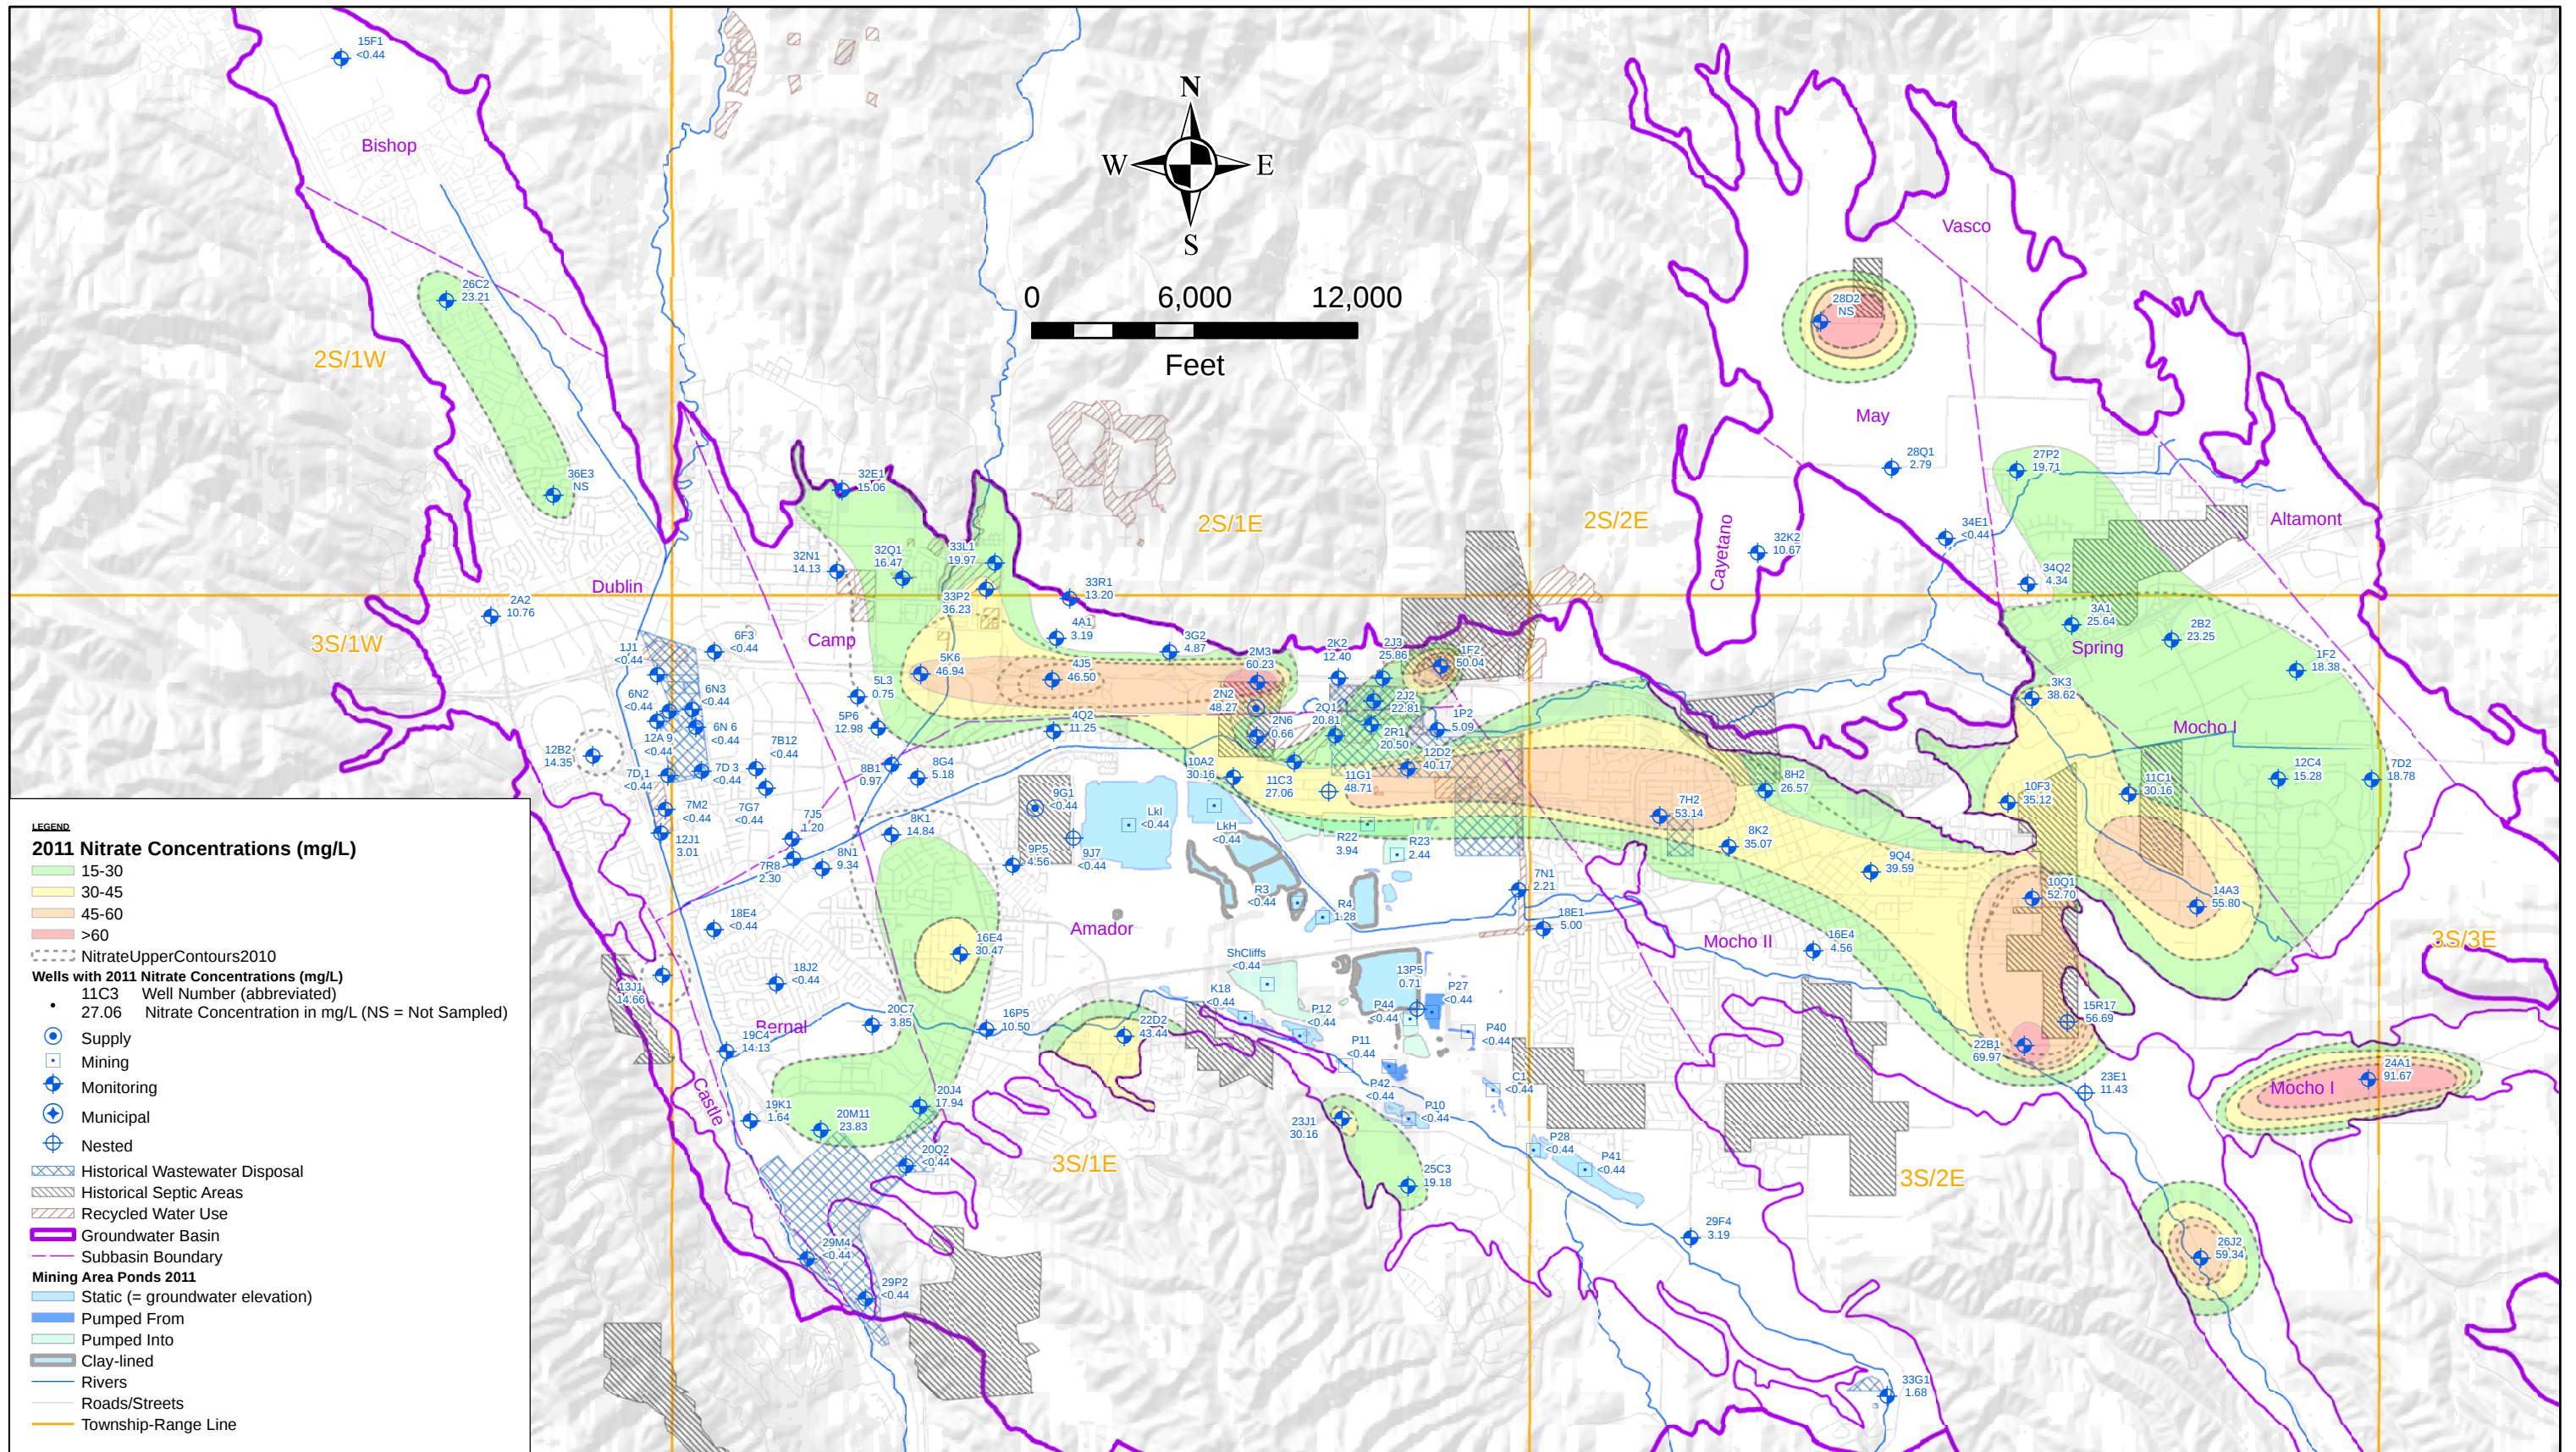
**Figure 3.2-10**  
**Nitrate Concentrations (mg/L)**  
**Upper Aquifer; 2011 Water Year**  
**Livermore Valley Groundwater Basin**

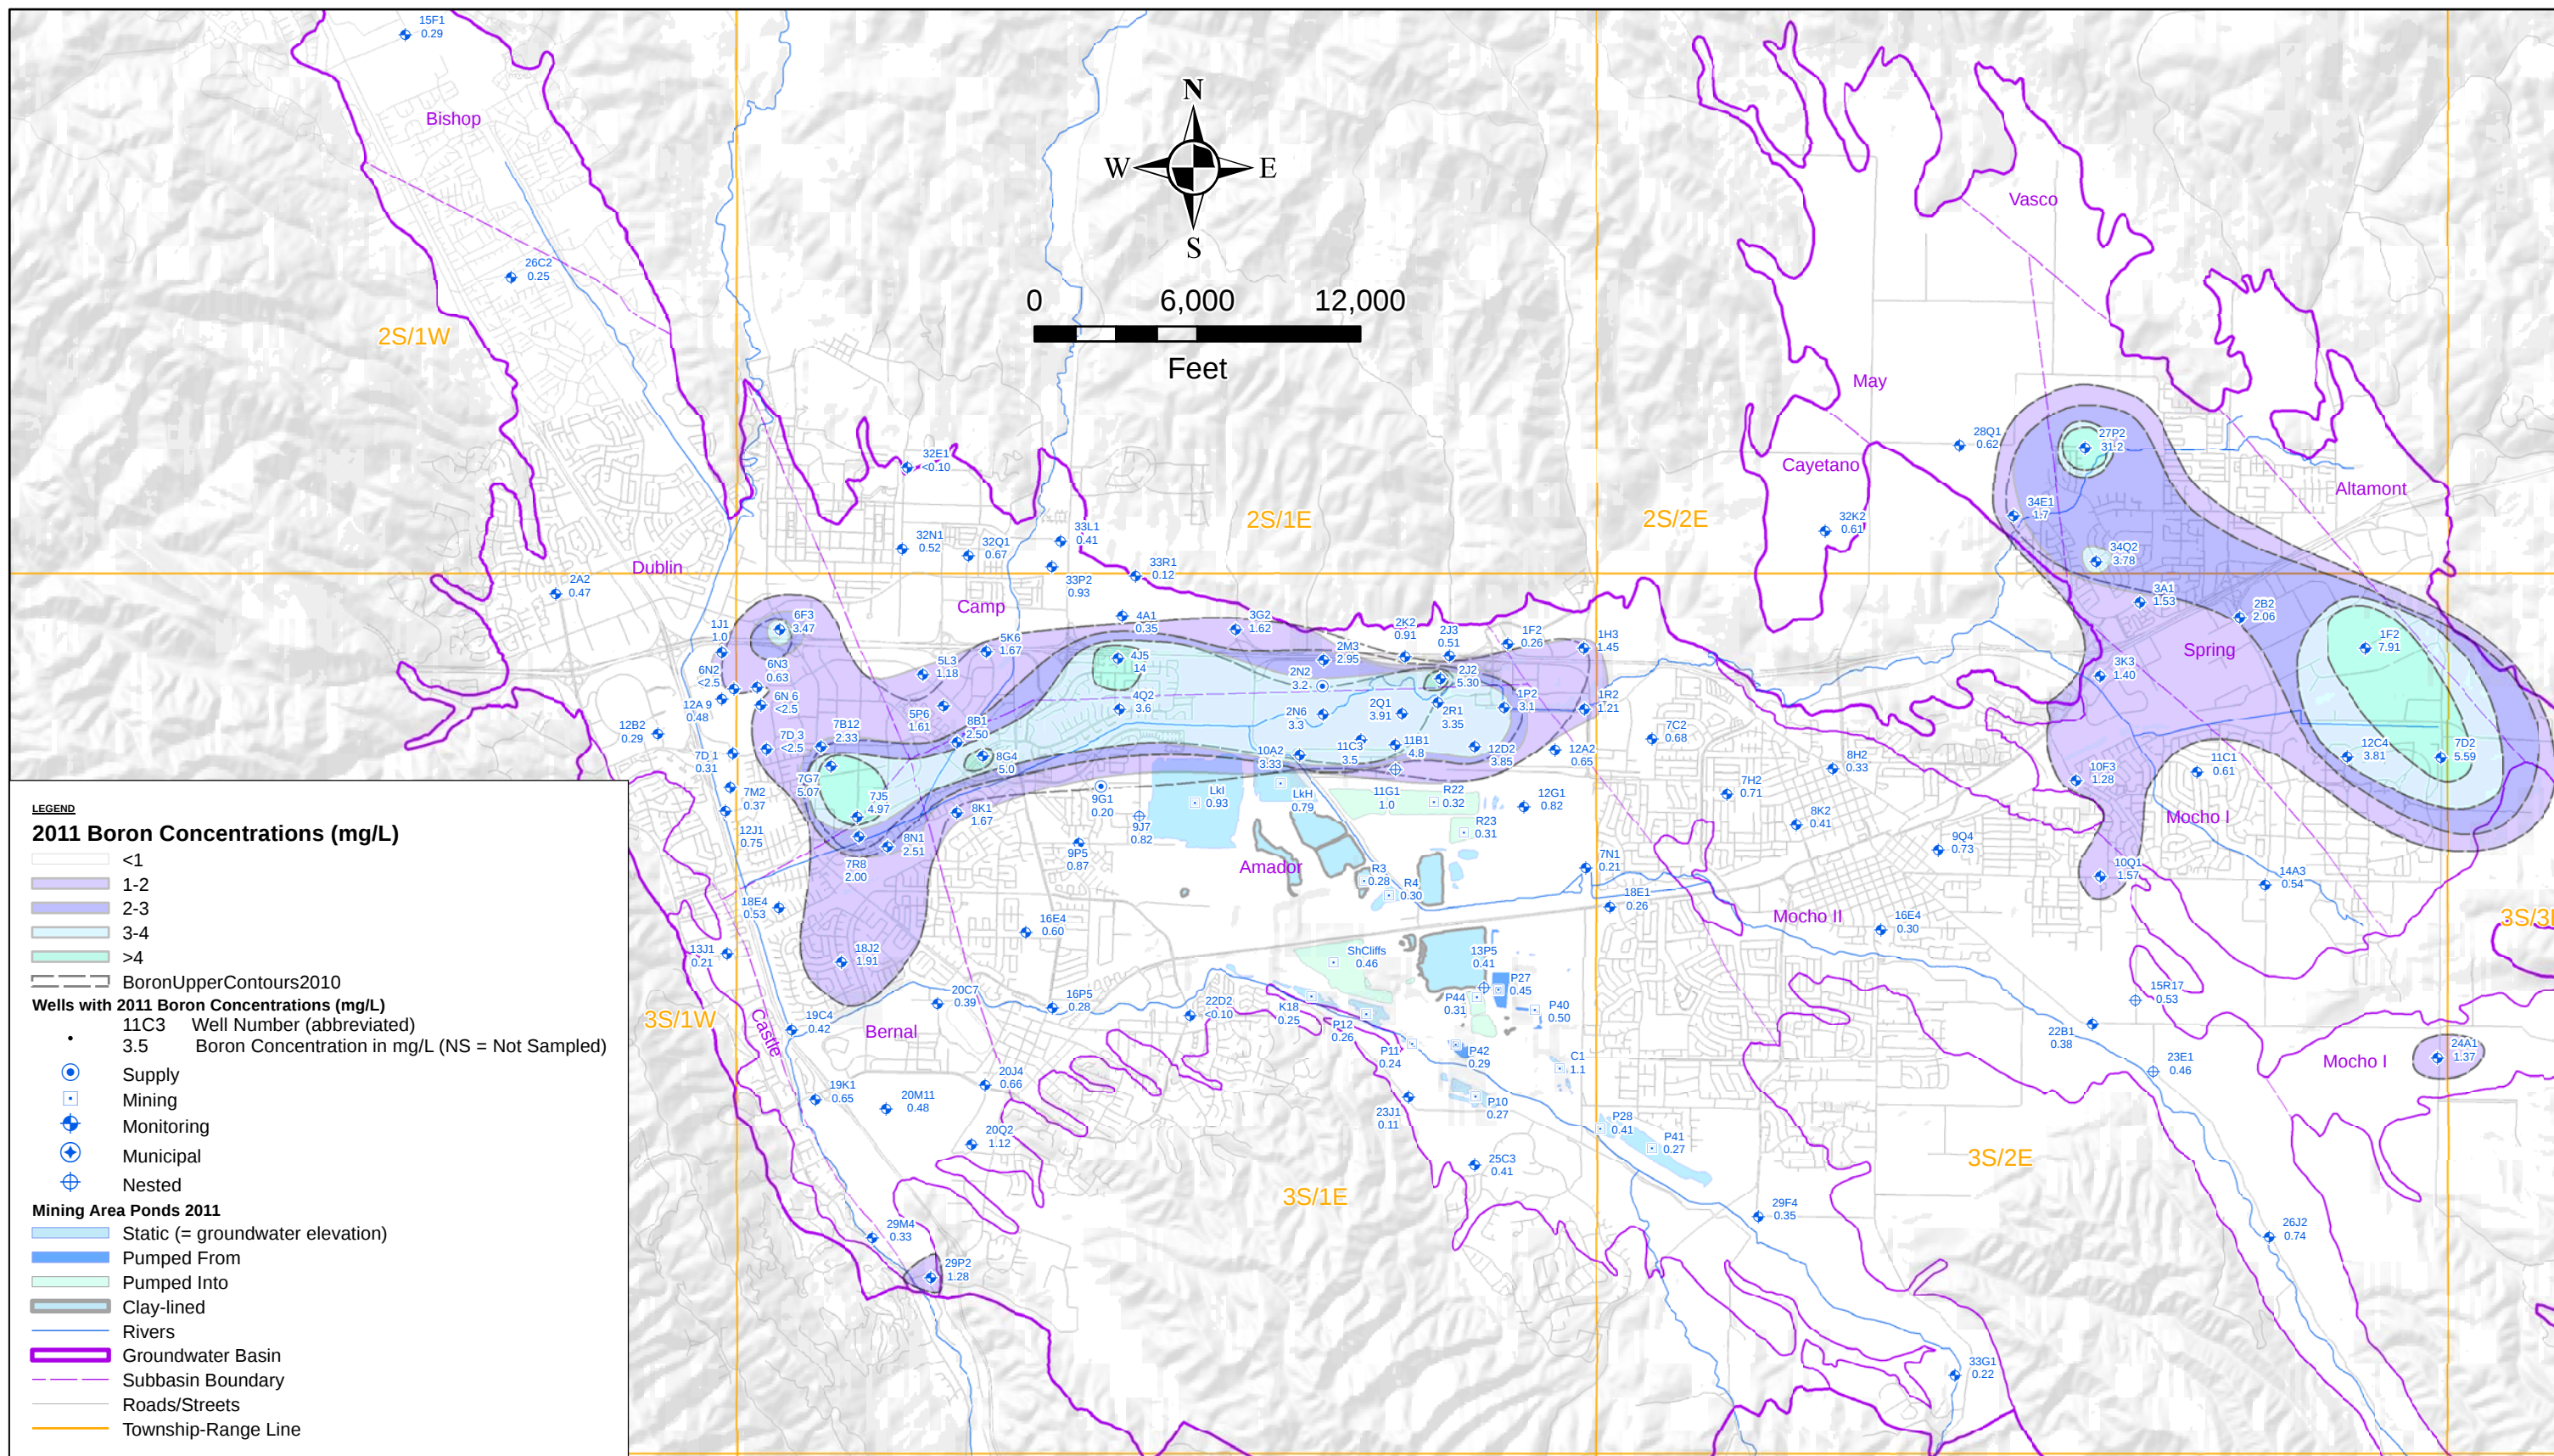
**Figure 3.2-11**  
**Boron Concentrations (mg/L)**  
**Upper Aquifer; 2011 Water Year**  
**Livermore Valley Groundwater Basin**
