**ZONE 7 WATER AGENCY**  
100 North Canyons Parkway  
Livermore, CA

**Figure 3.2-6**  
**Groundwater Gradient Map**  
**Lower Aquifer; Spring 2010 (April)**  
**Livermore Valley Groundwater Basin**

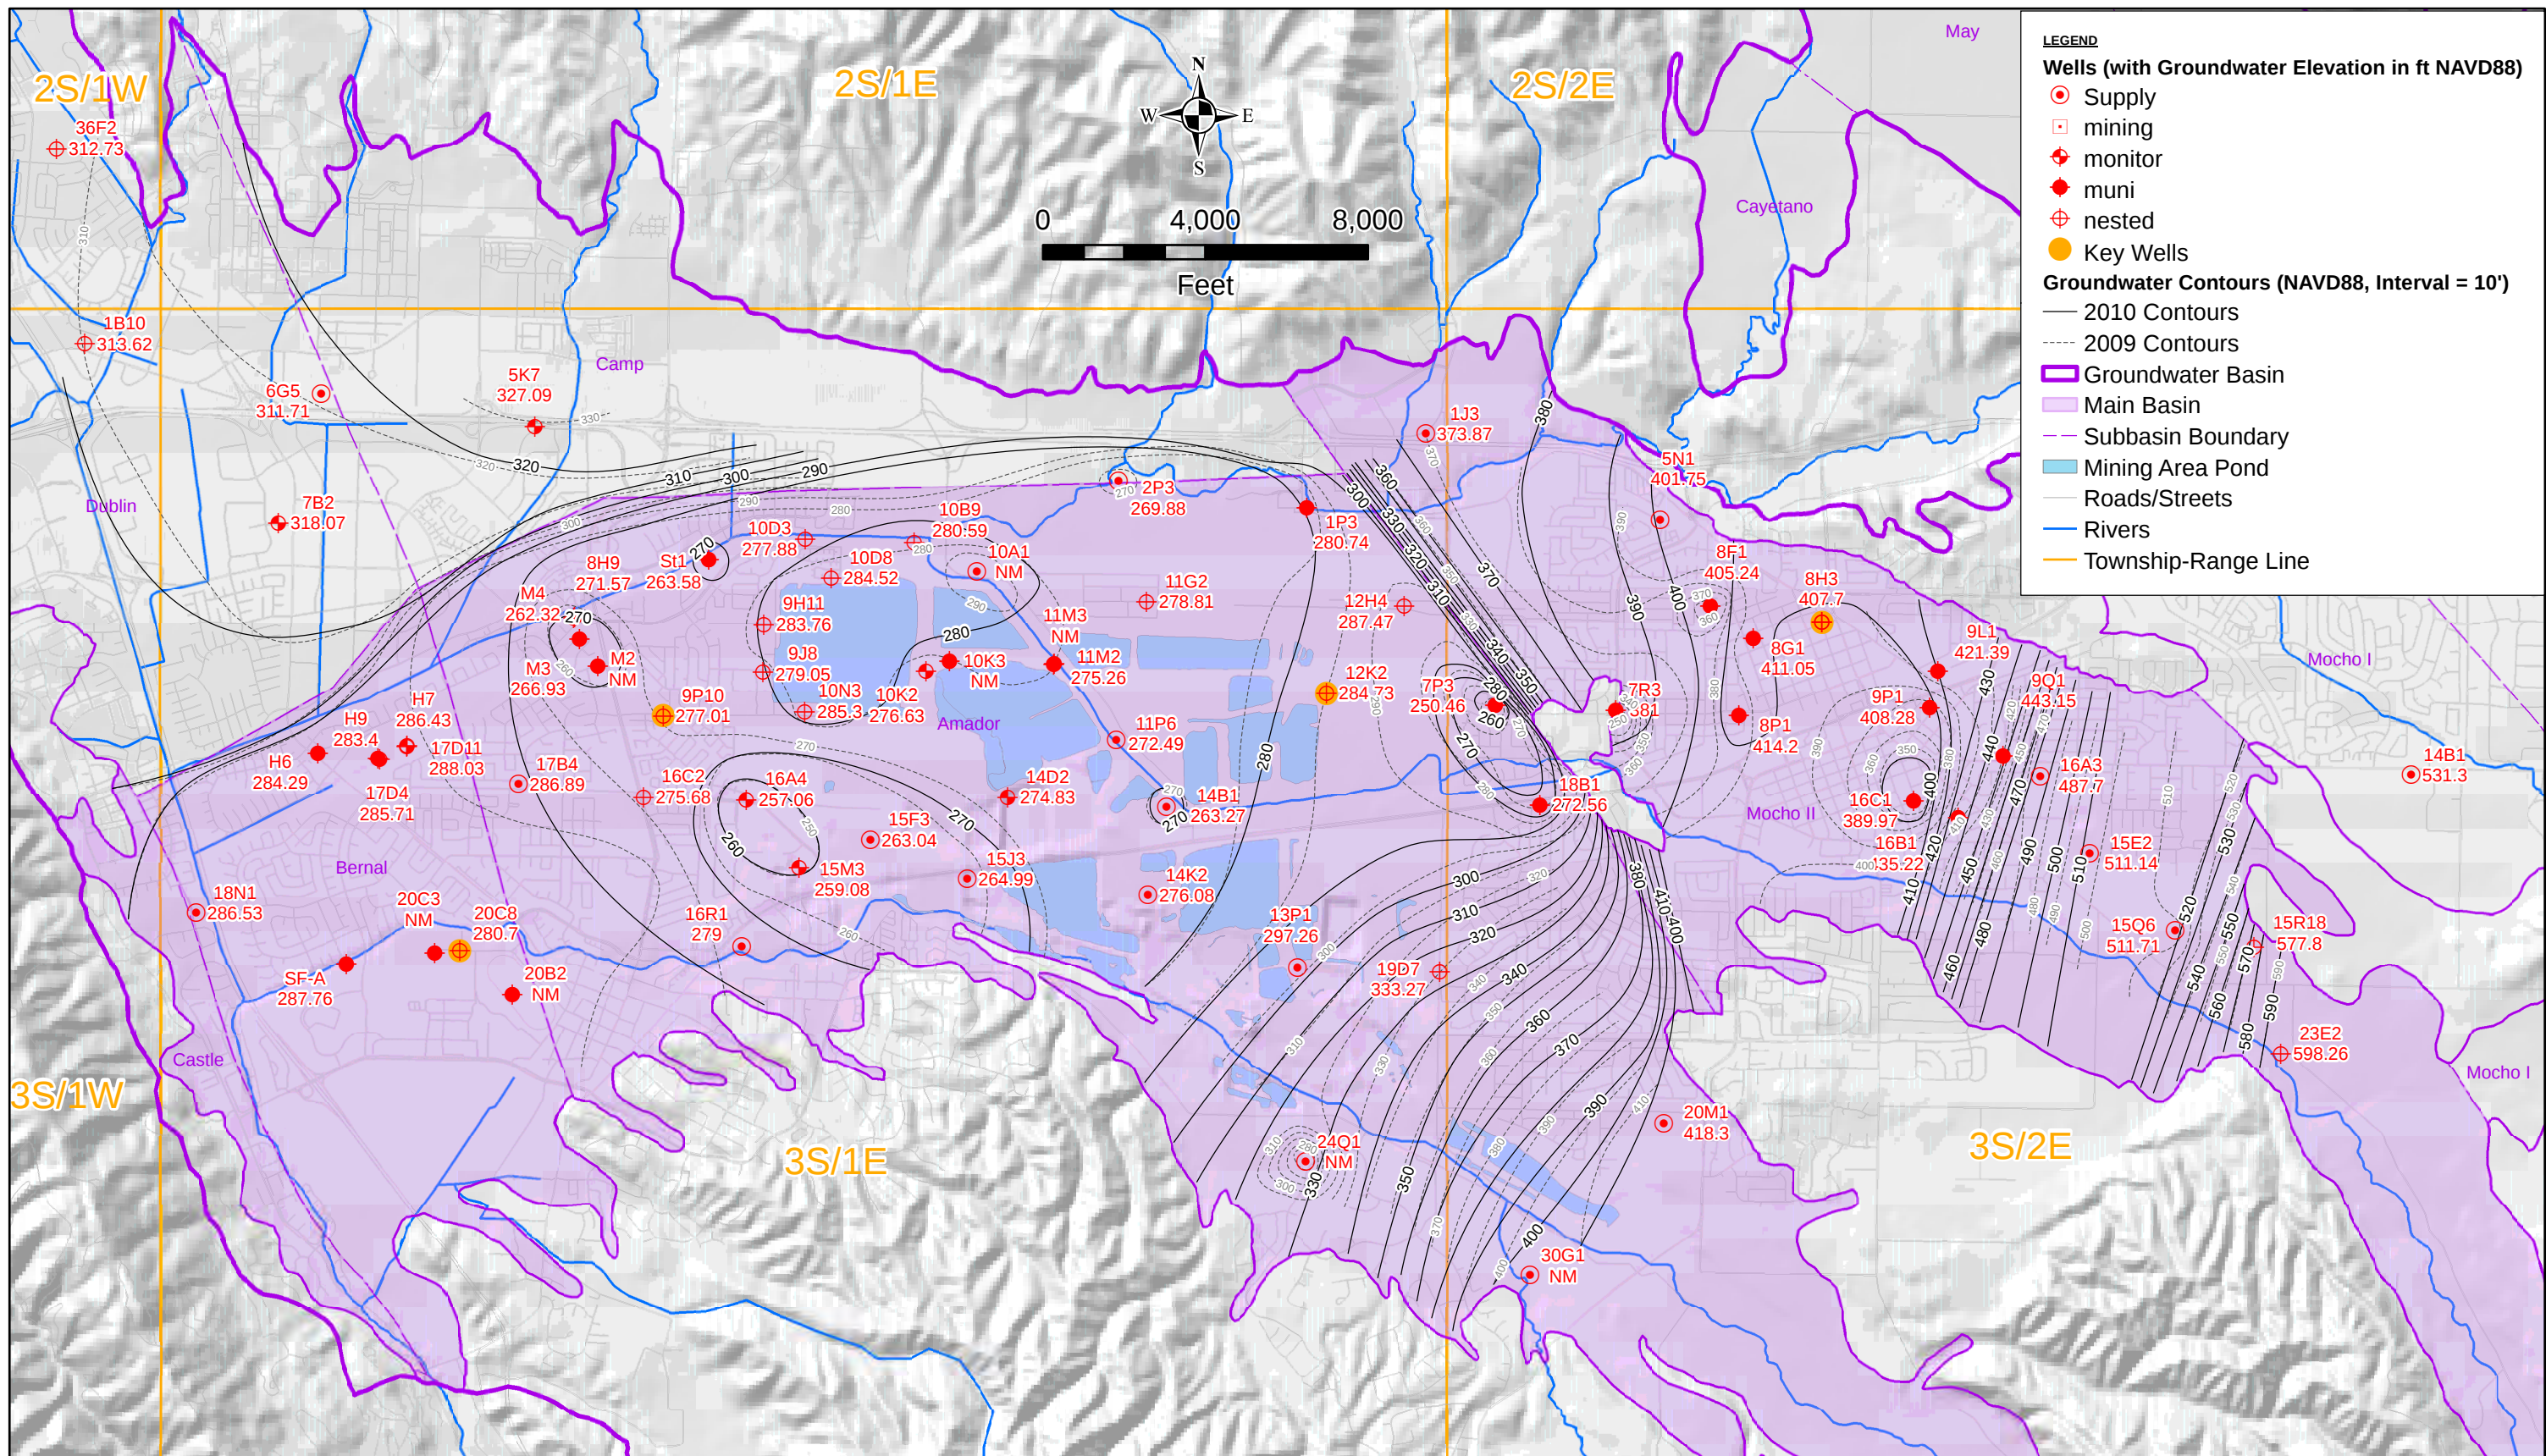
**Figure 3.2-7**  
**Groundwater Gradient Map**  
**Lower Aquifer; Fall 2010 (September)**  
**Livermore Valley Groundwater Basin**

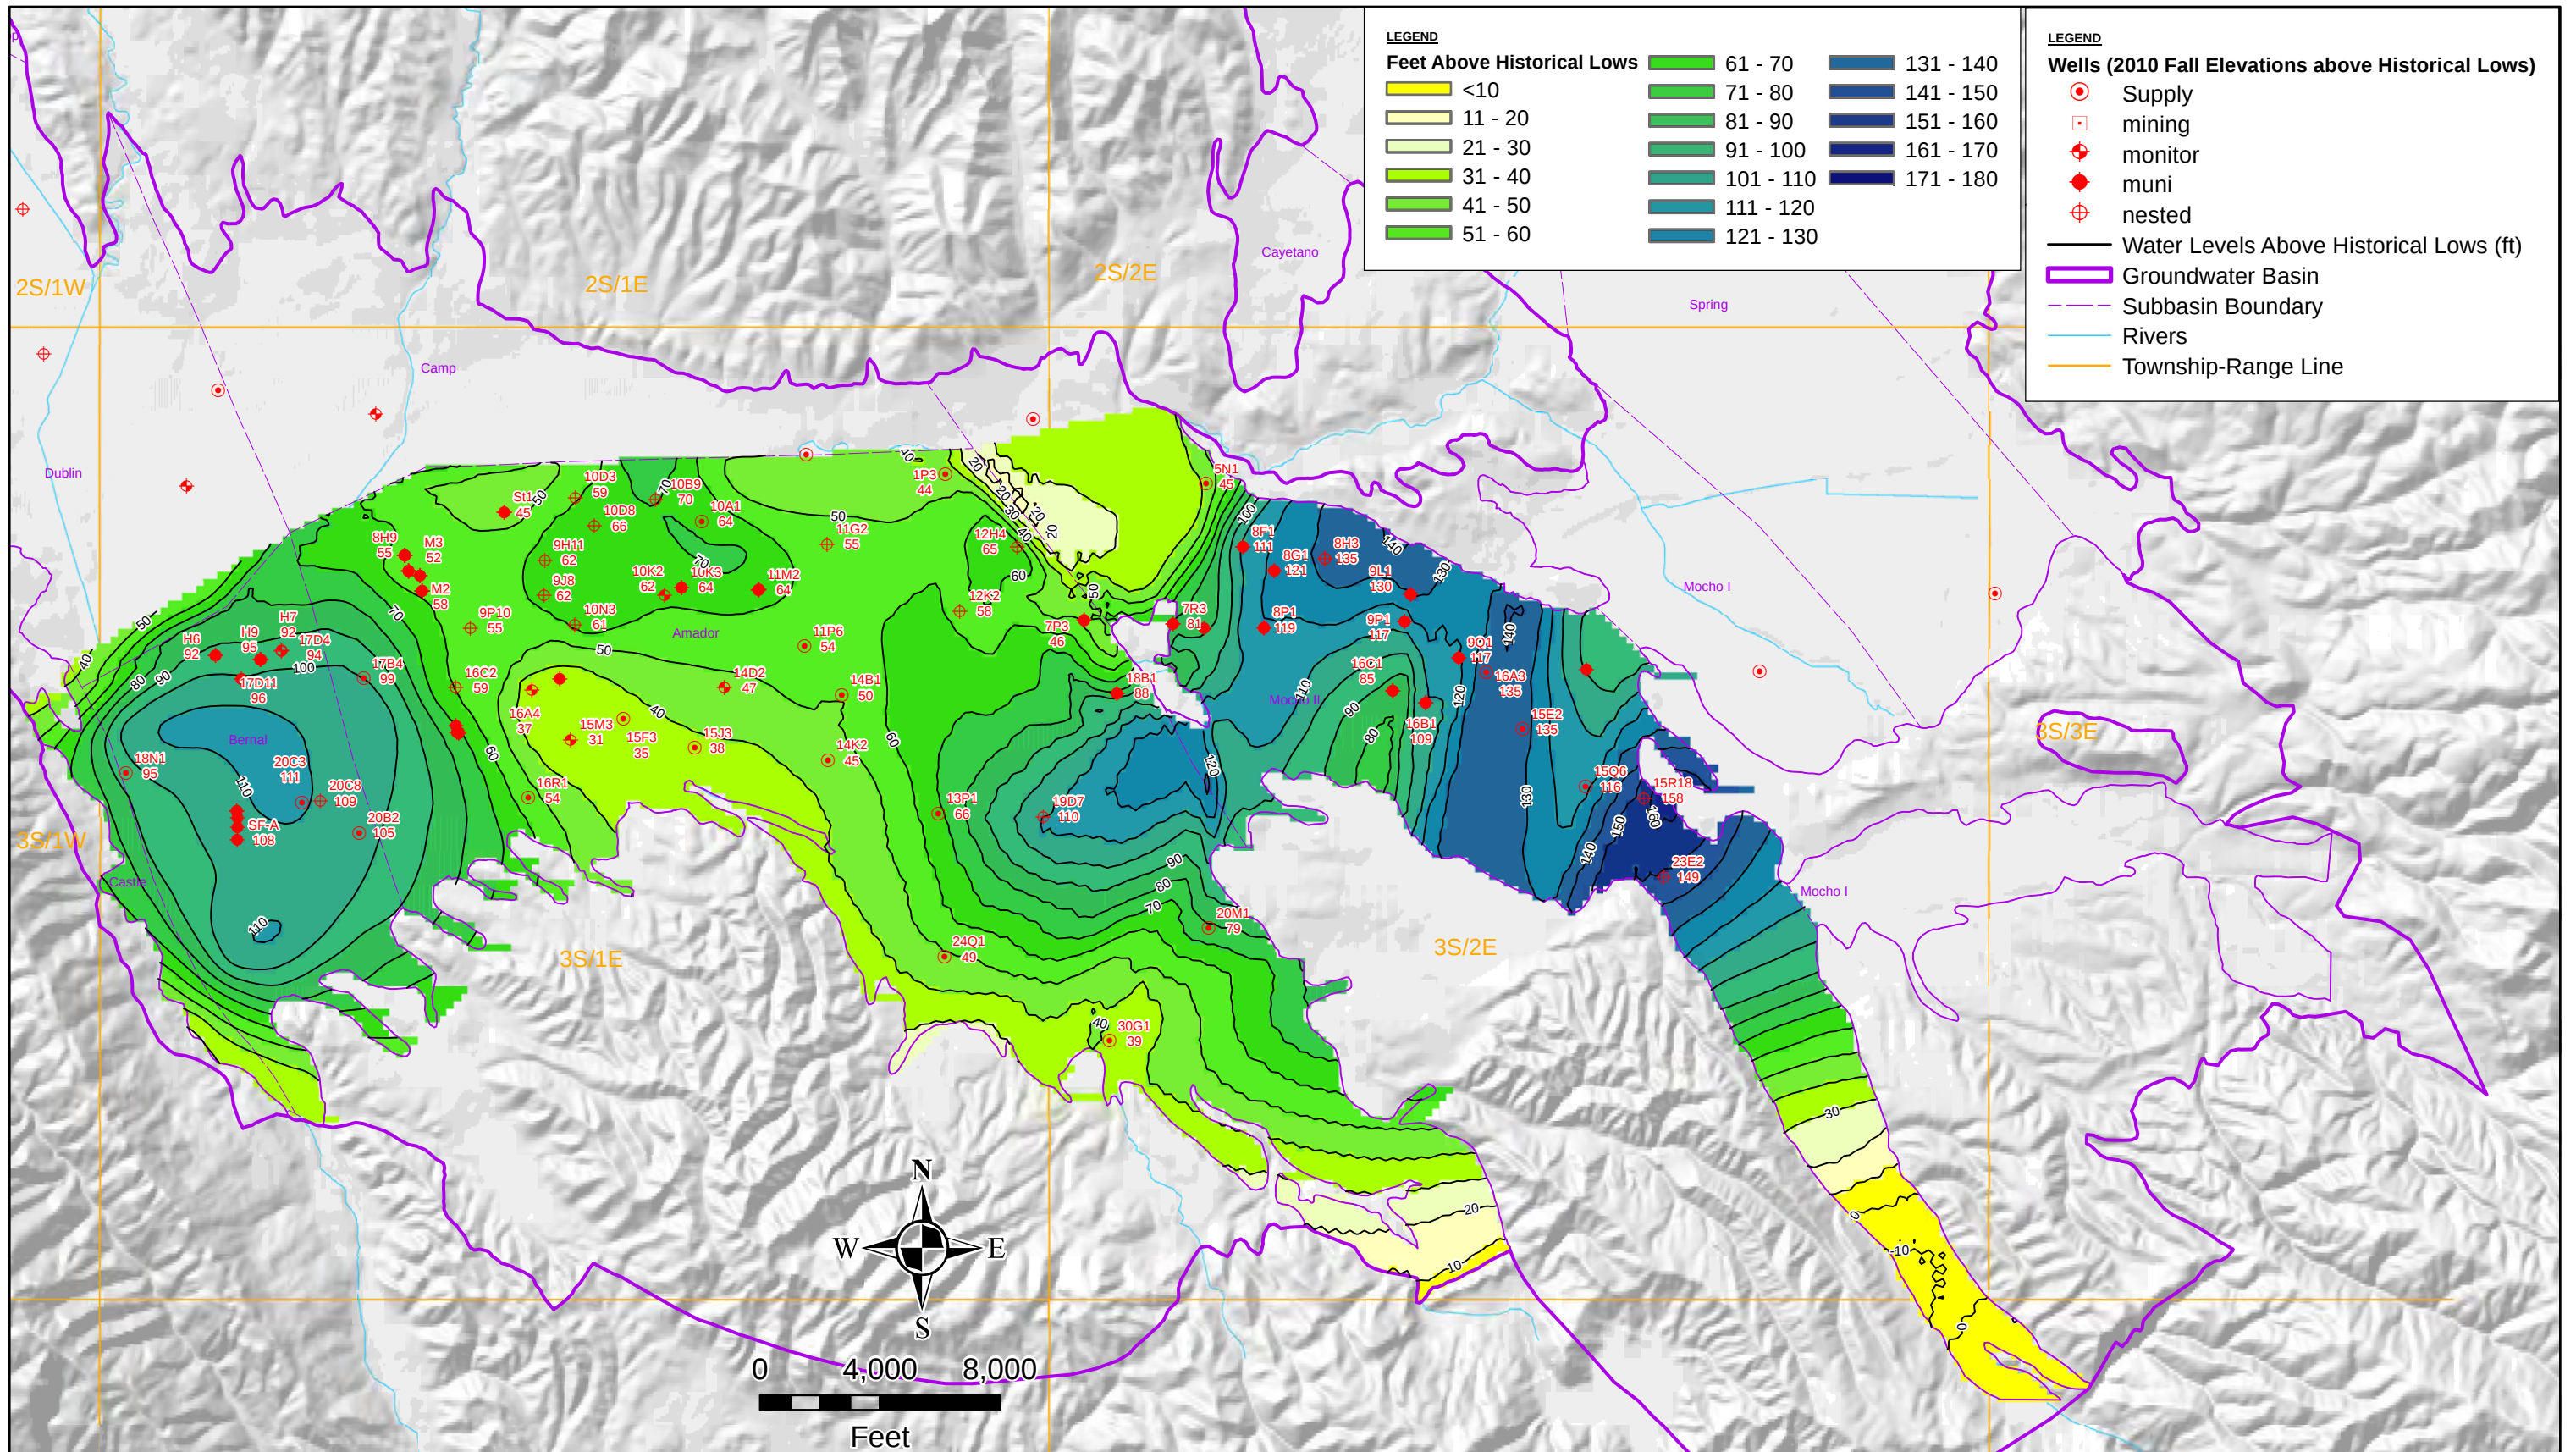
**Figure 3.2-8**  
**Groundwater Levels Above Historical Lows**  
**Lower Aquifer; Fall 2010 (September)**  
**Livermore Valley Groundwater Basin**
