**ZONE 7 WATER AGENCY**  
100 North Canyons Parkway  
Livermore, CA

**Figure 3.2-1**  
**Zone 7 Groundwater Program**  
**Wells in 2010 Program**  
**Livermore Valley Groundwater Basin**

**FIGURE 3.2-2  
ZONE 7 WATER AGENCY  
Key Well Hydrographs - Historical  
Western Portion of Main Basin**

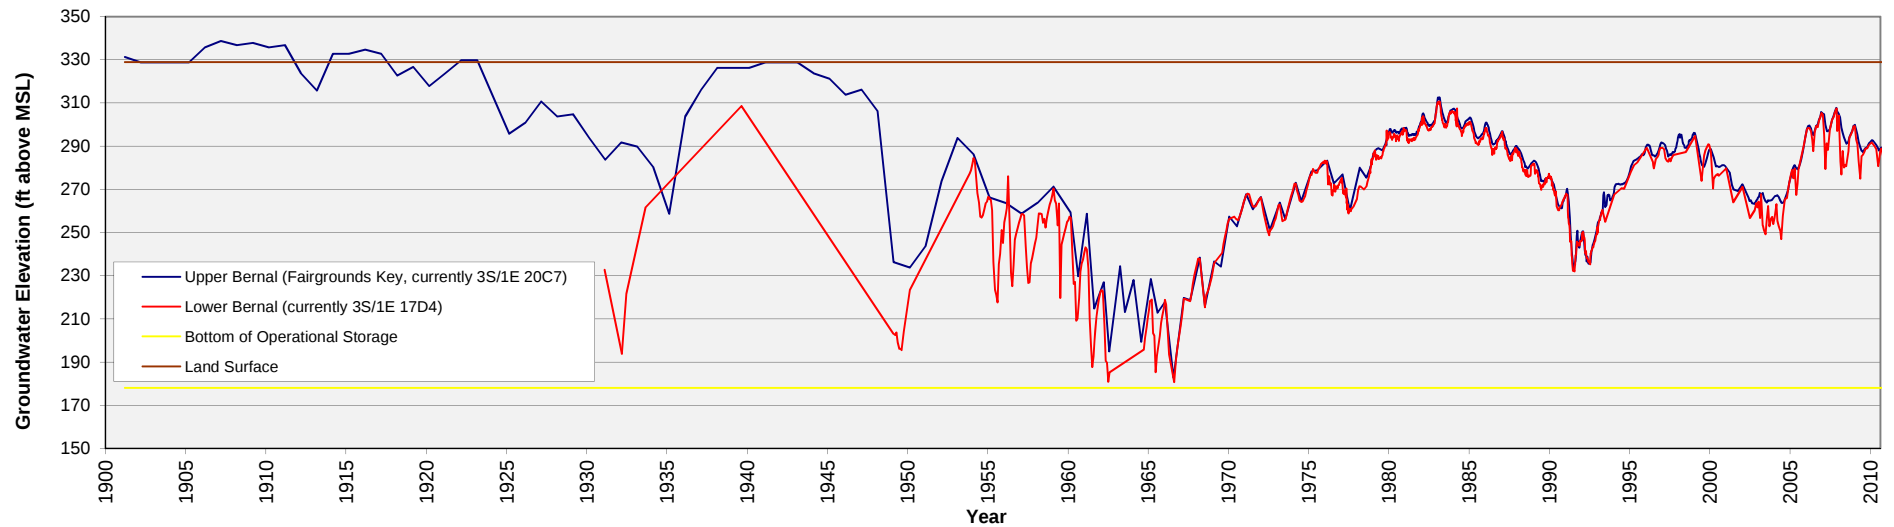
**BERNAL SUBBASIN KEY WELLS**

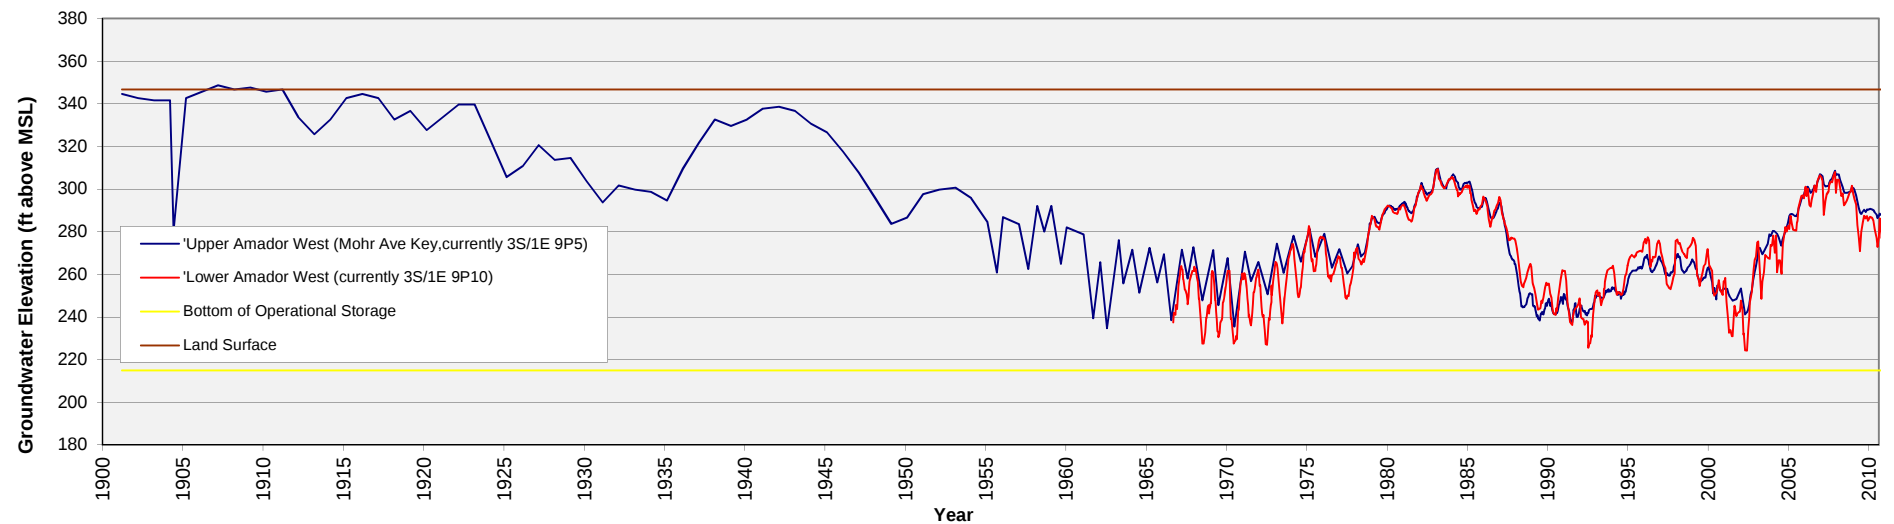
**AMADOR WEST SUBBASIN KEY WELLS**

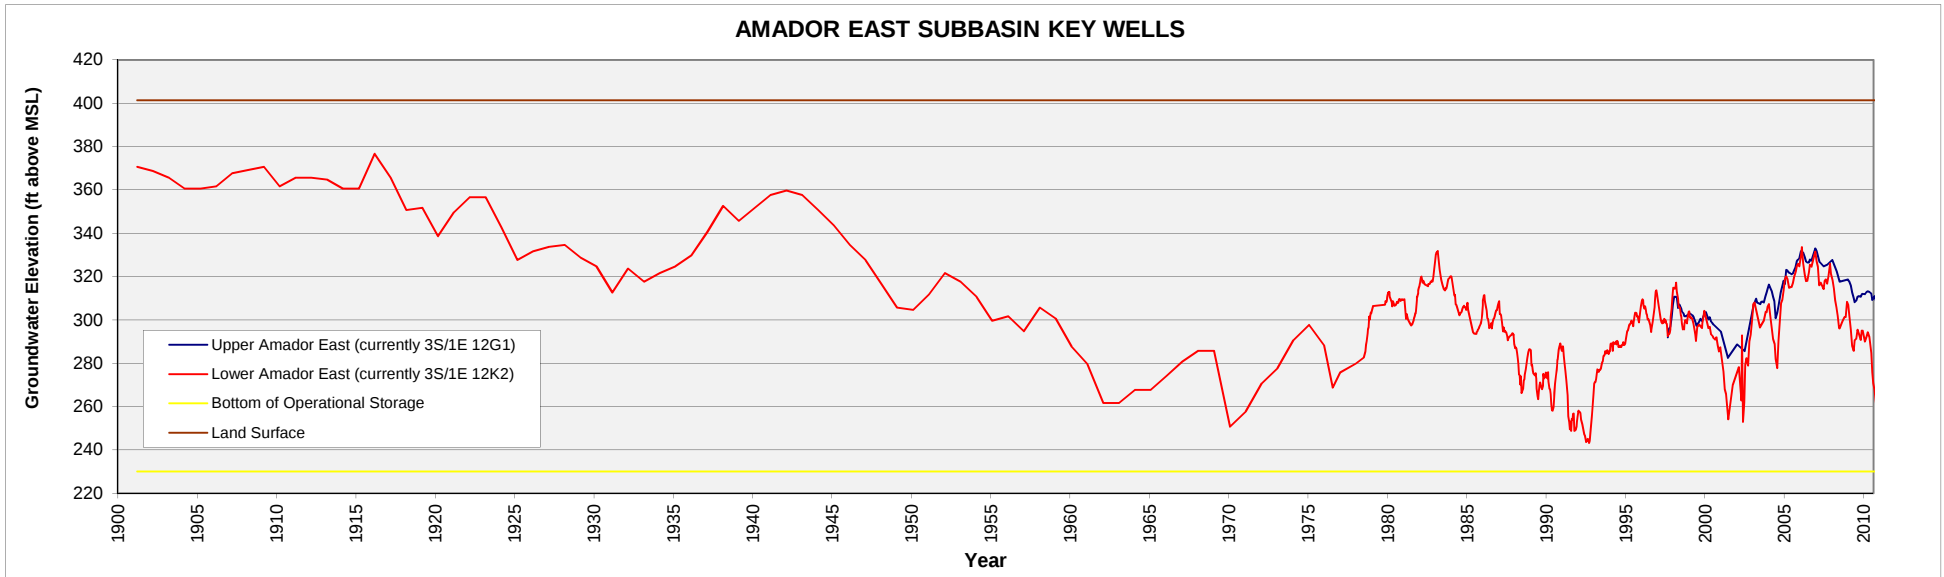
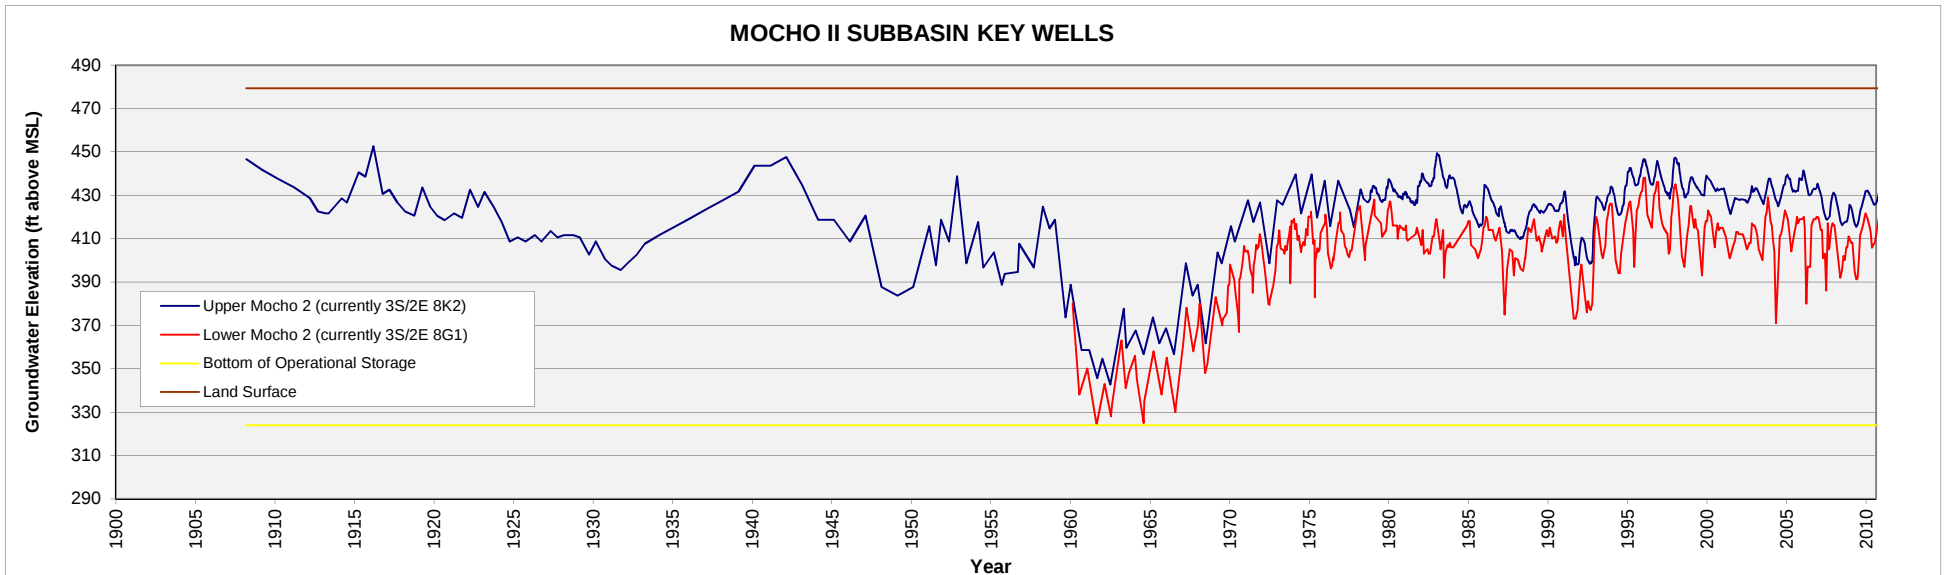
**FIGURE 3.2-2  
ZONE 7 WATER AGENCY  
Key Well Hydrographs - Historical  
Eastern Portion of Main Basin**

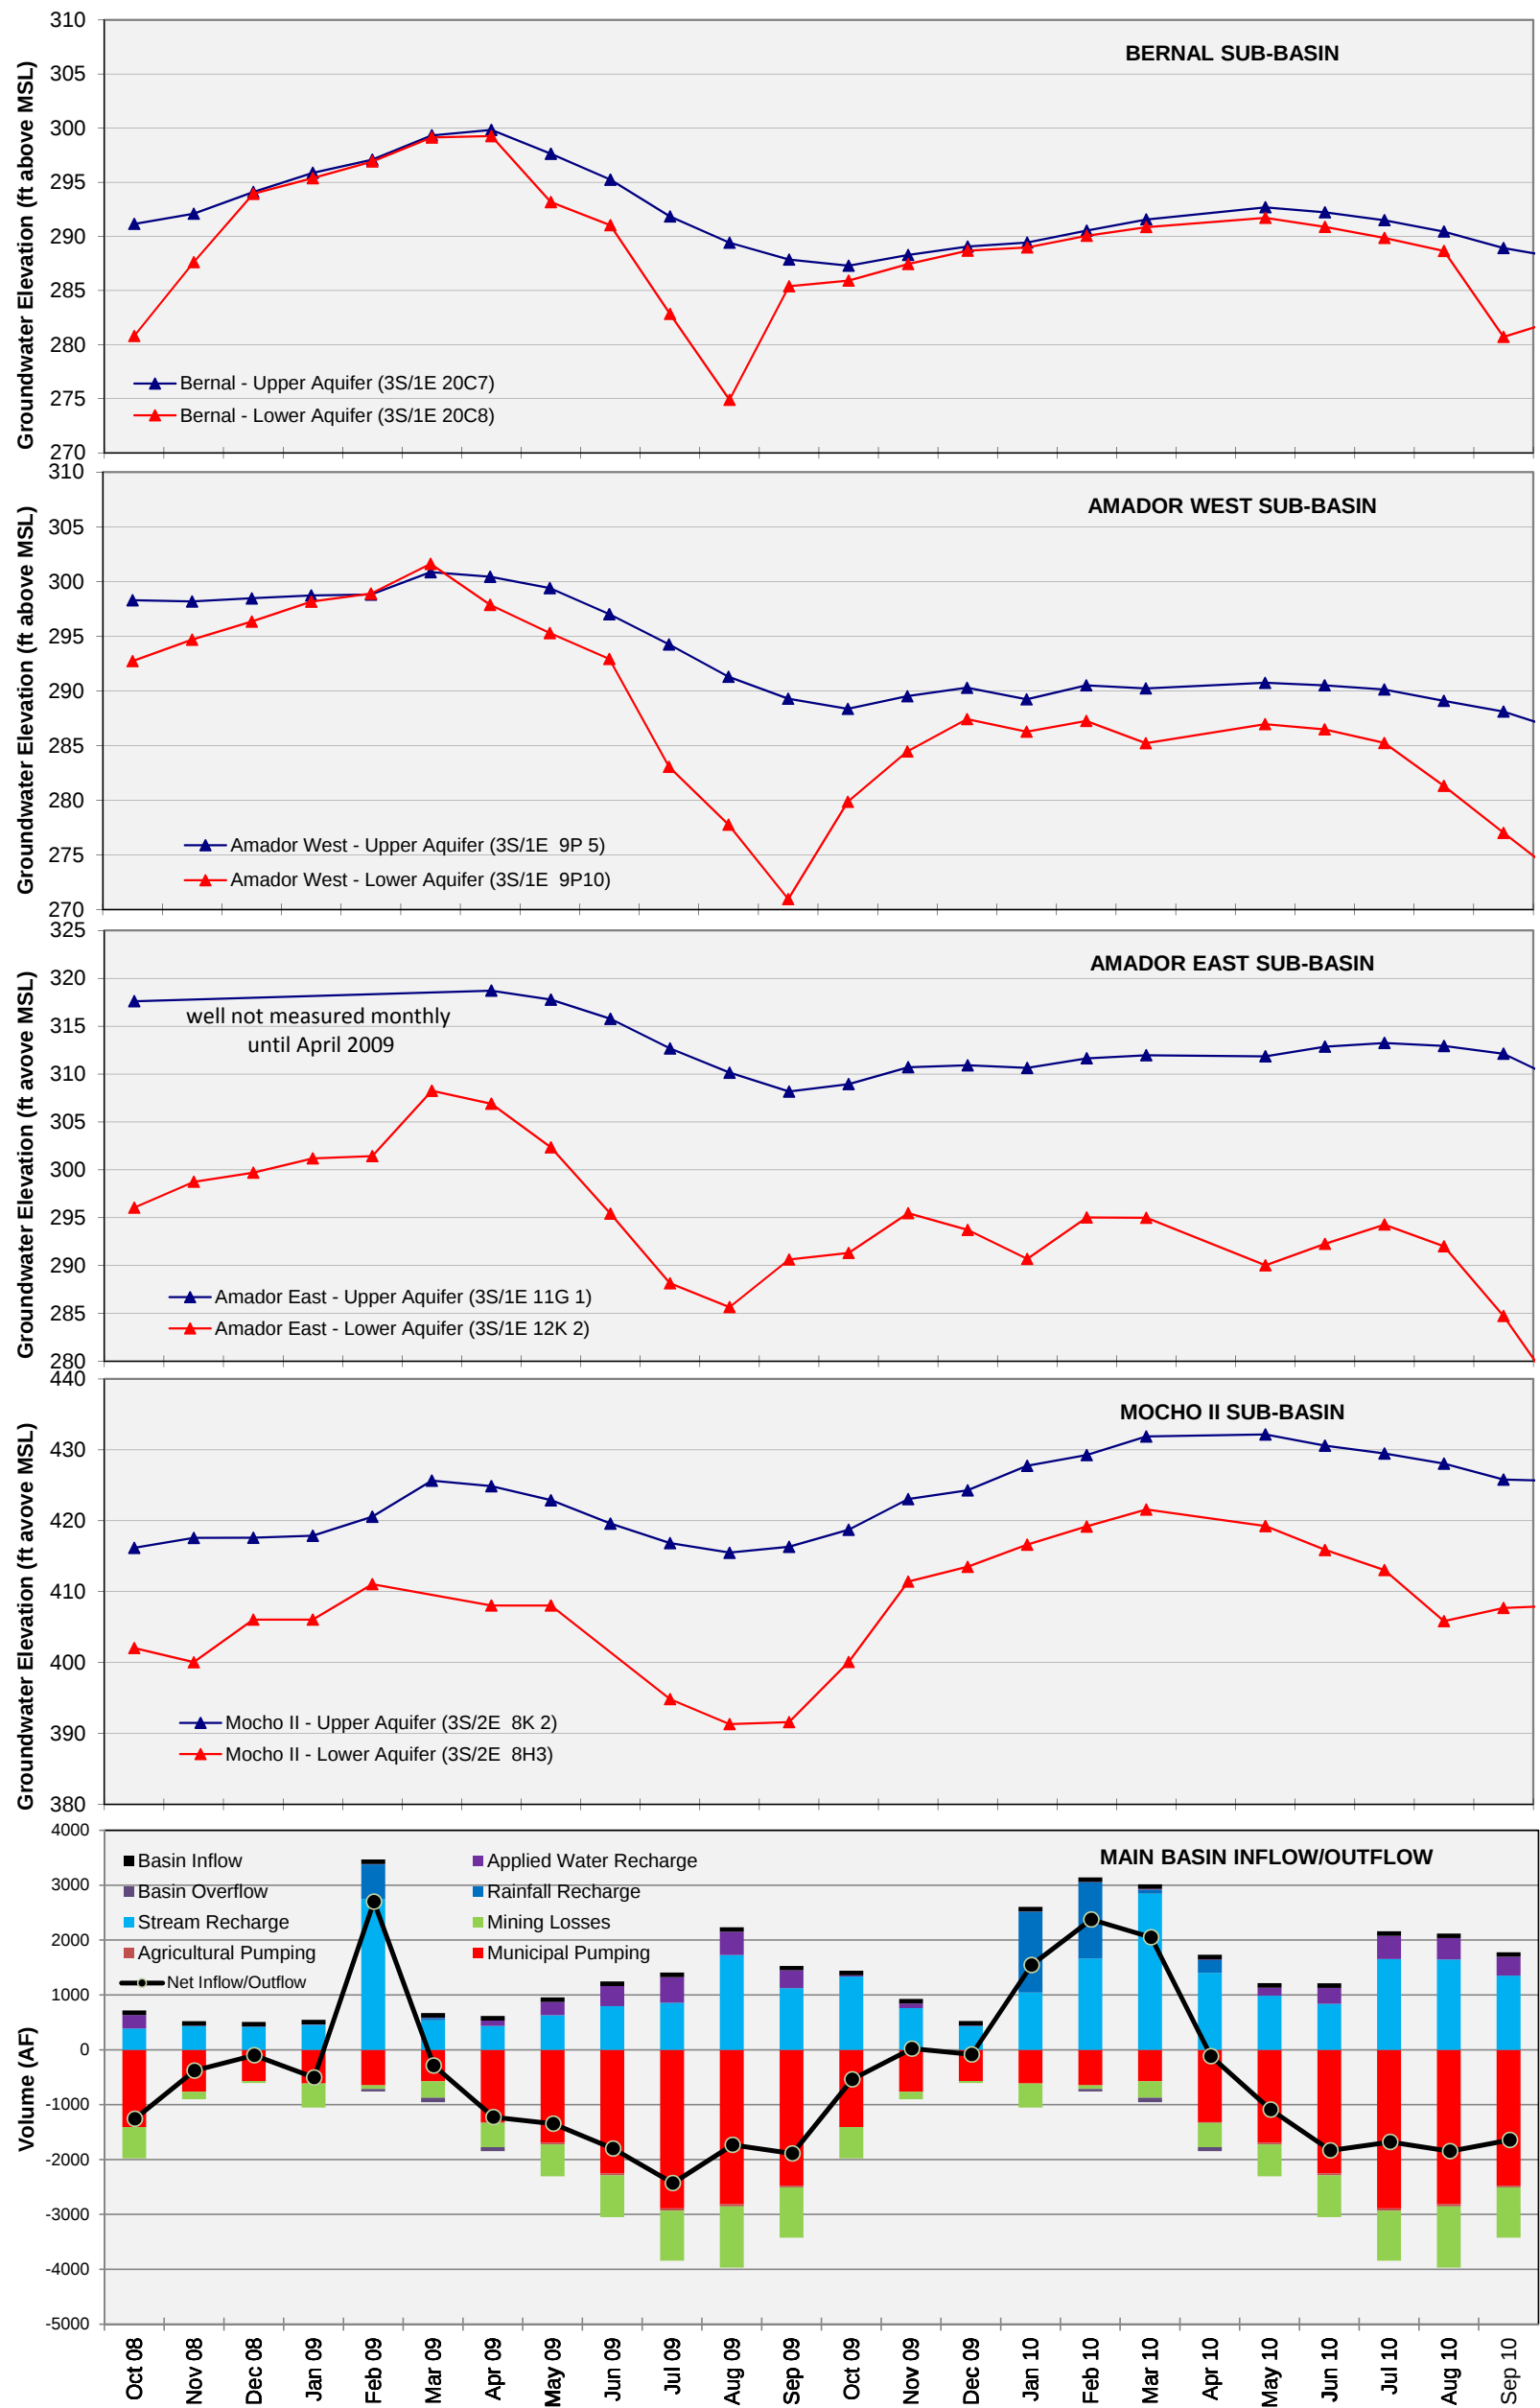
Figure 3.2-3  
Key Well Hydrographs  
2009 to 2010 Water Years

Notes: No water levels taken in April 2010  
11G1 not measured monthly until April 2009

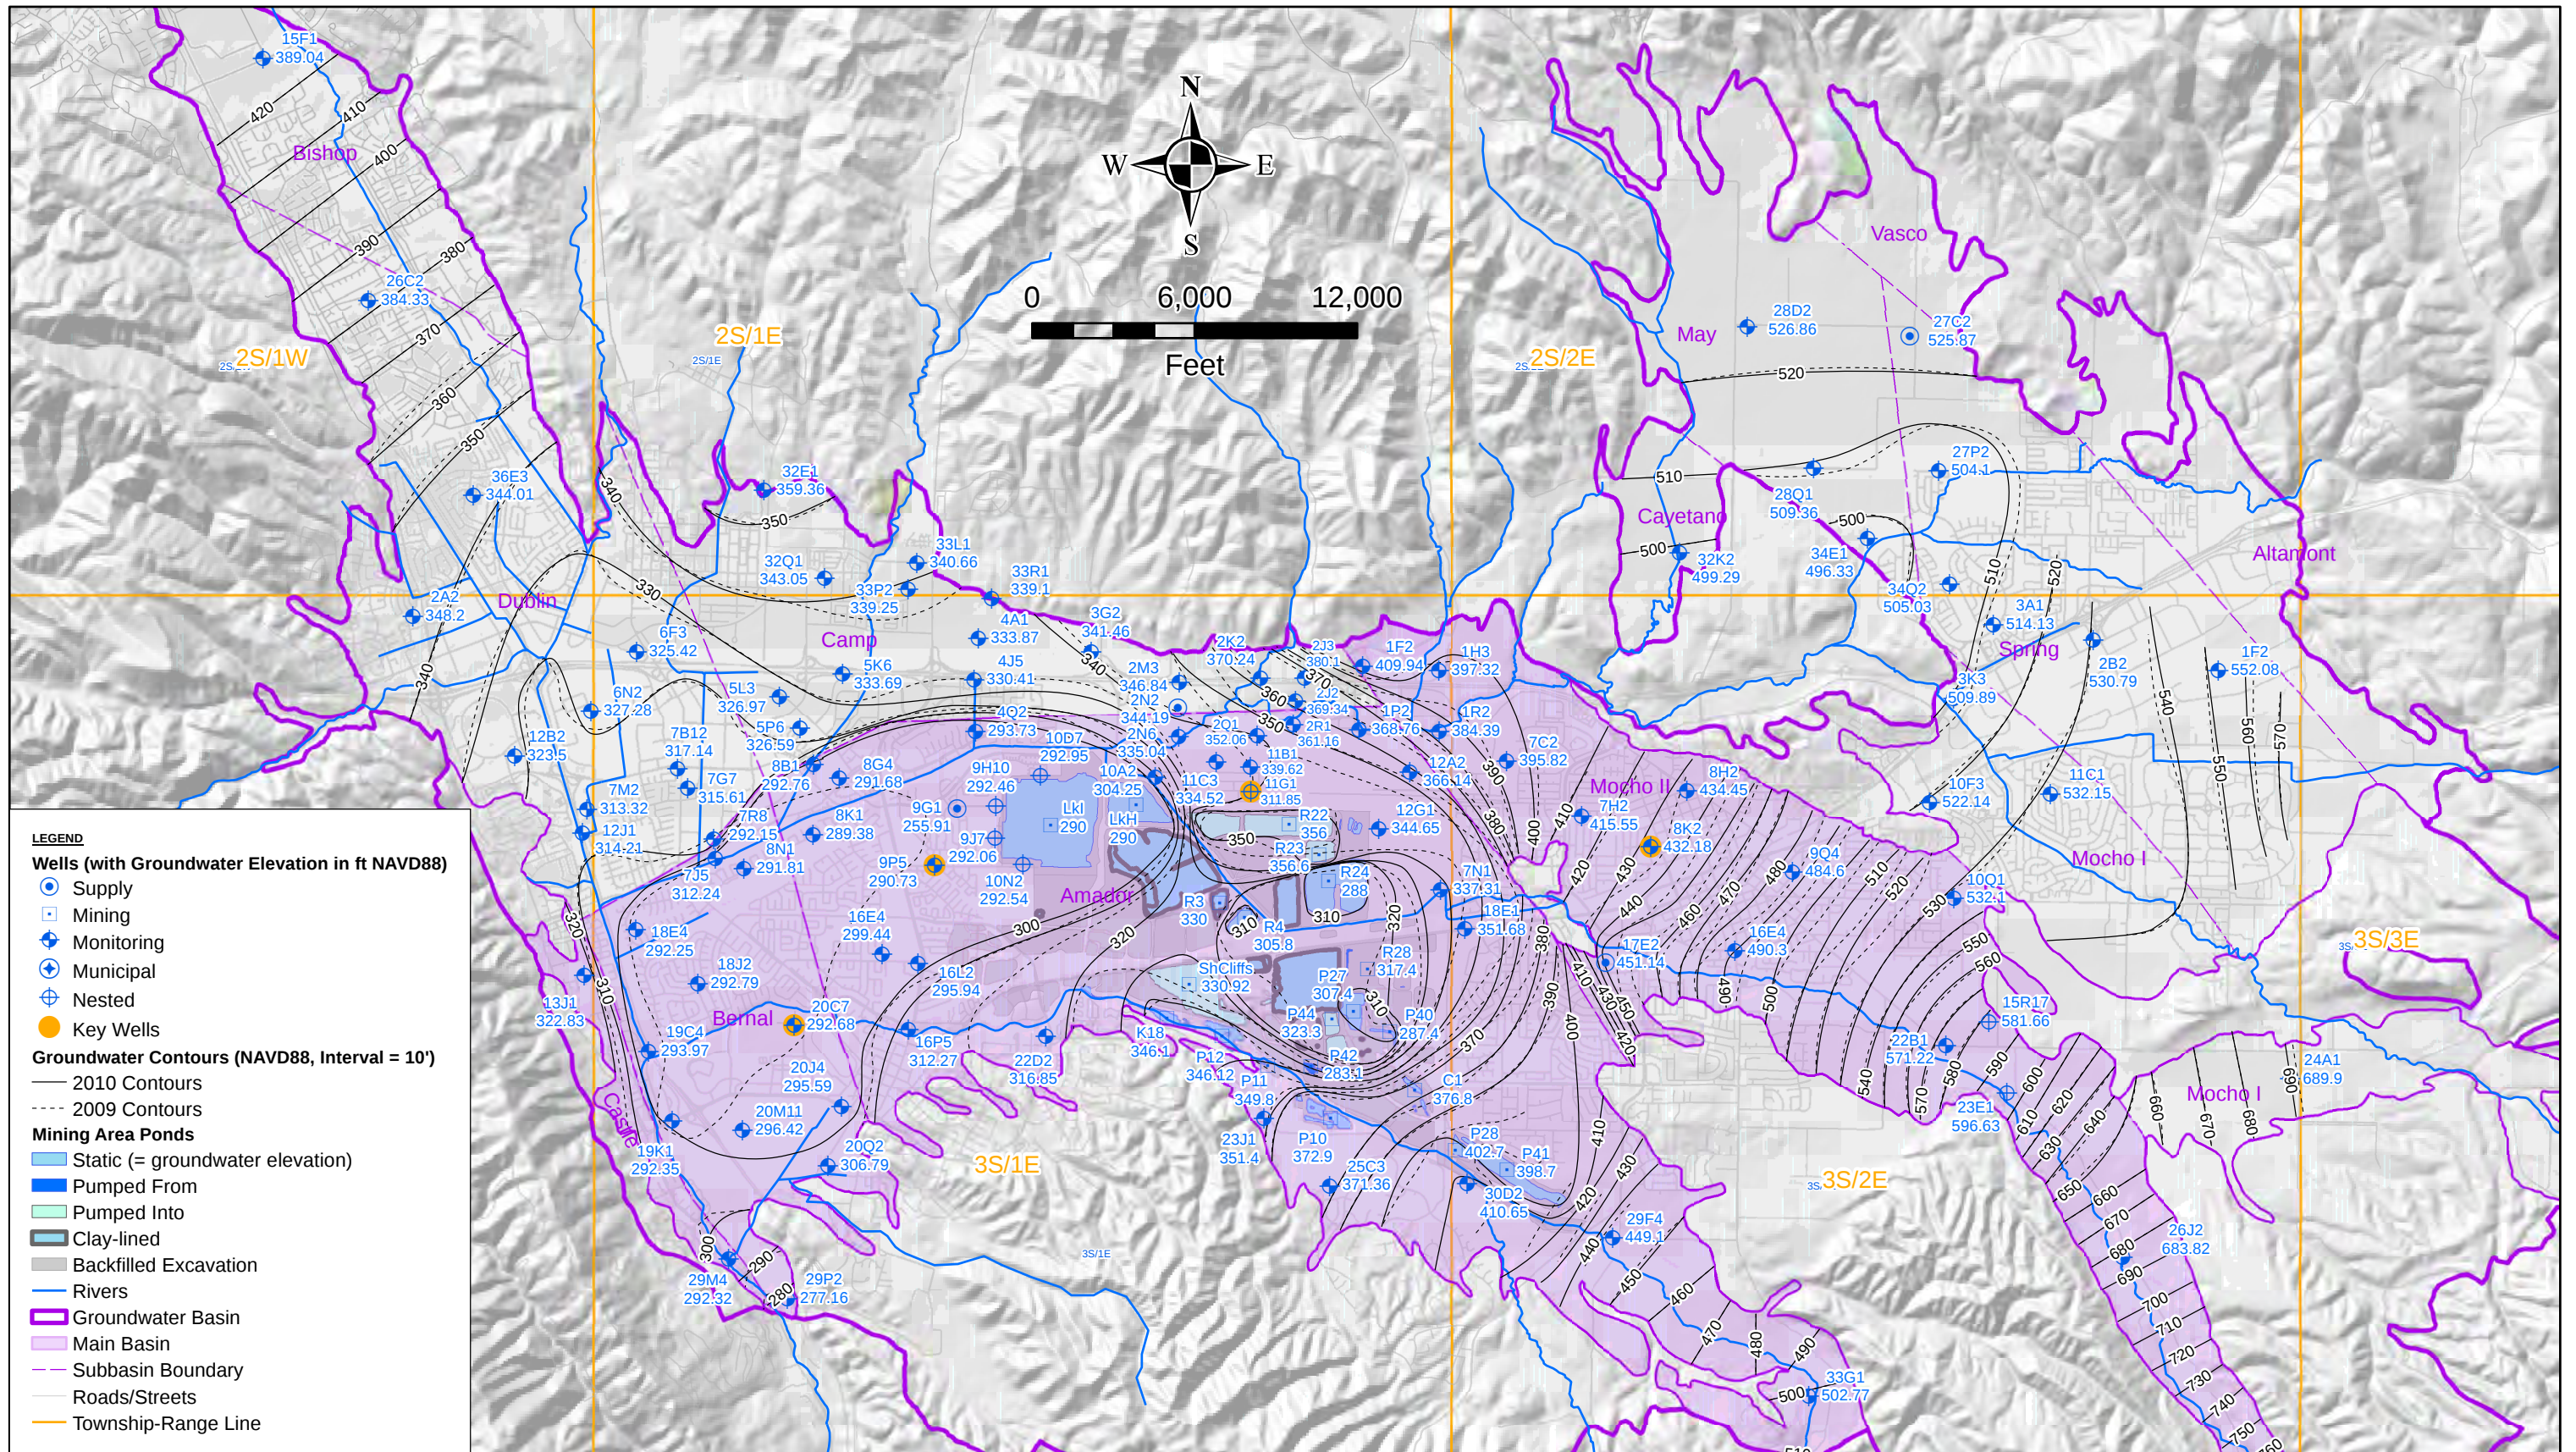
**Figure 3.2-4**  
**Groundwater Gradient Map**  
**Upper Aquifer; Spring 2010 (April)**  
**Livermore Valley Groundwater Basin**

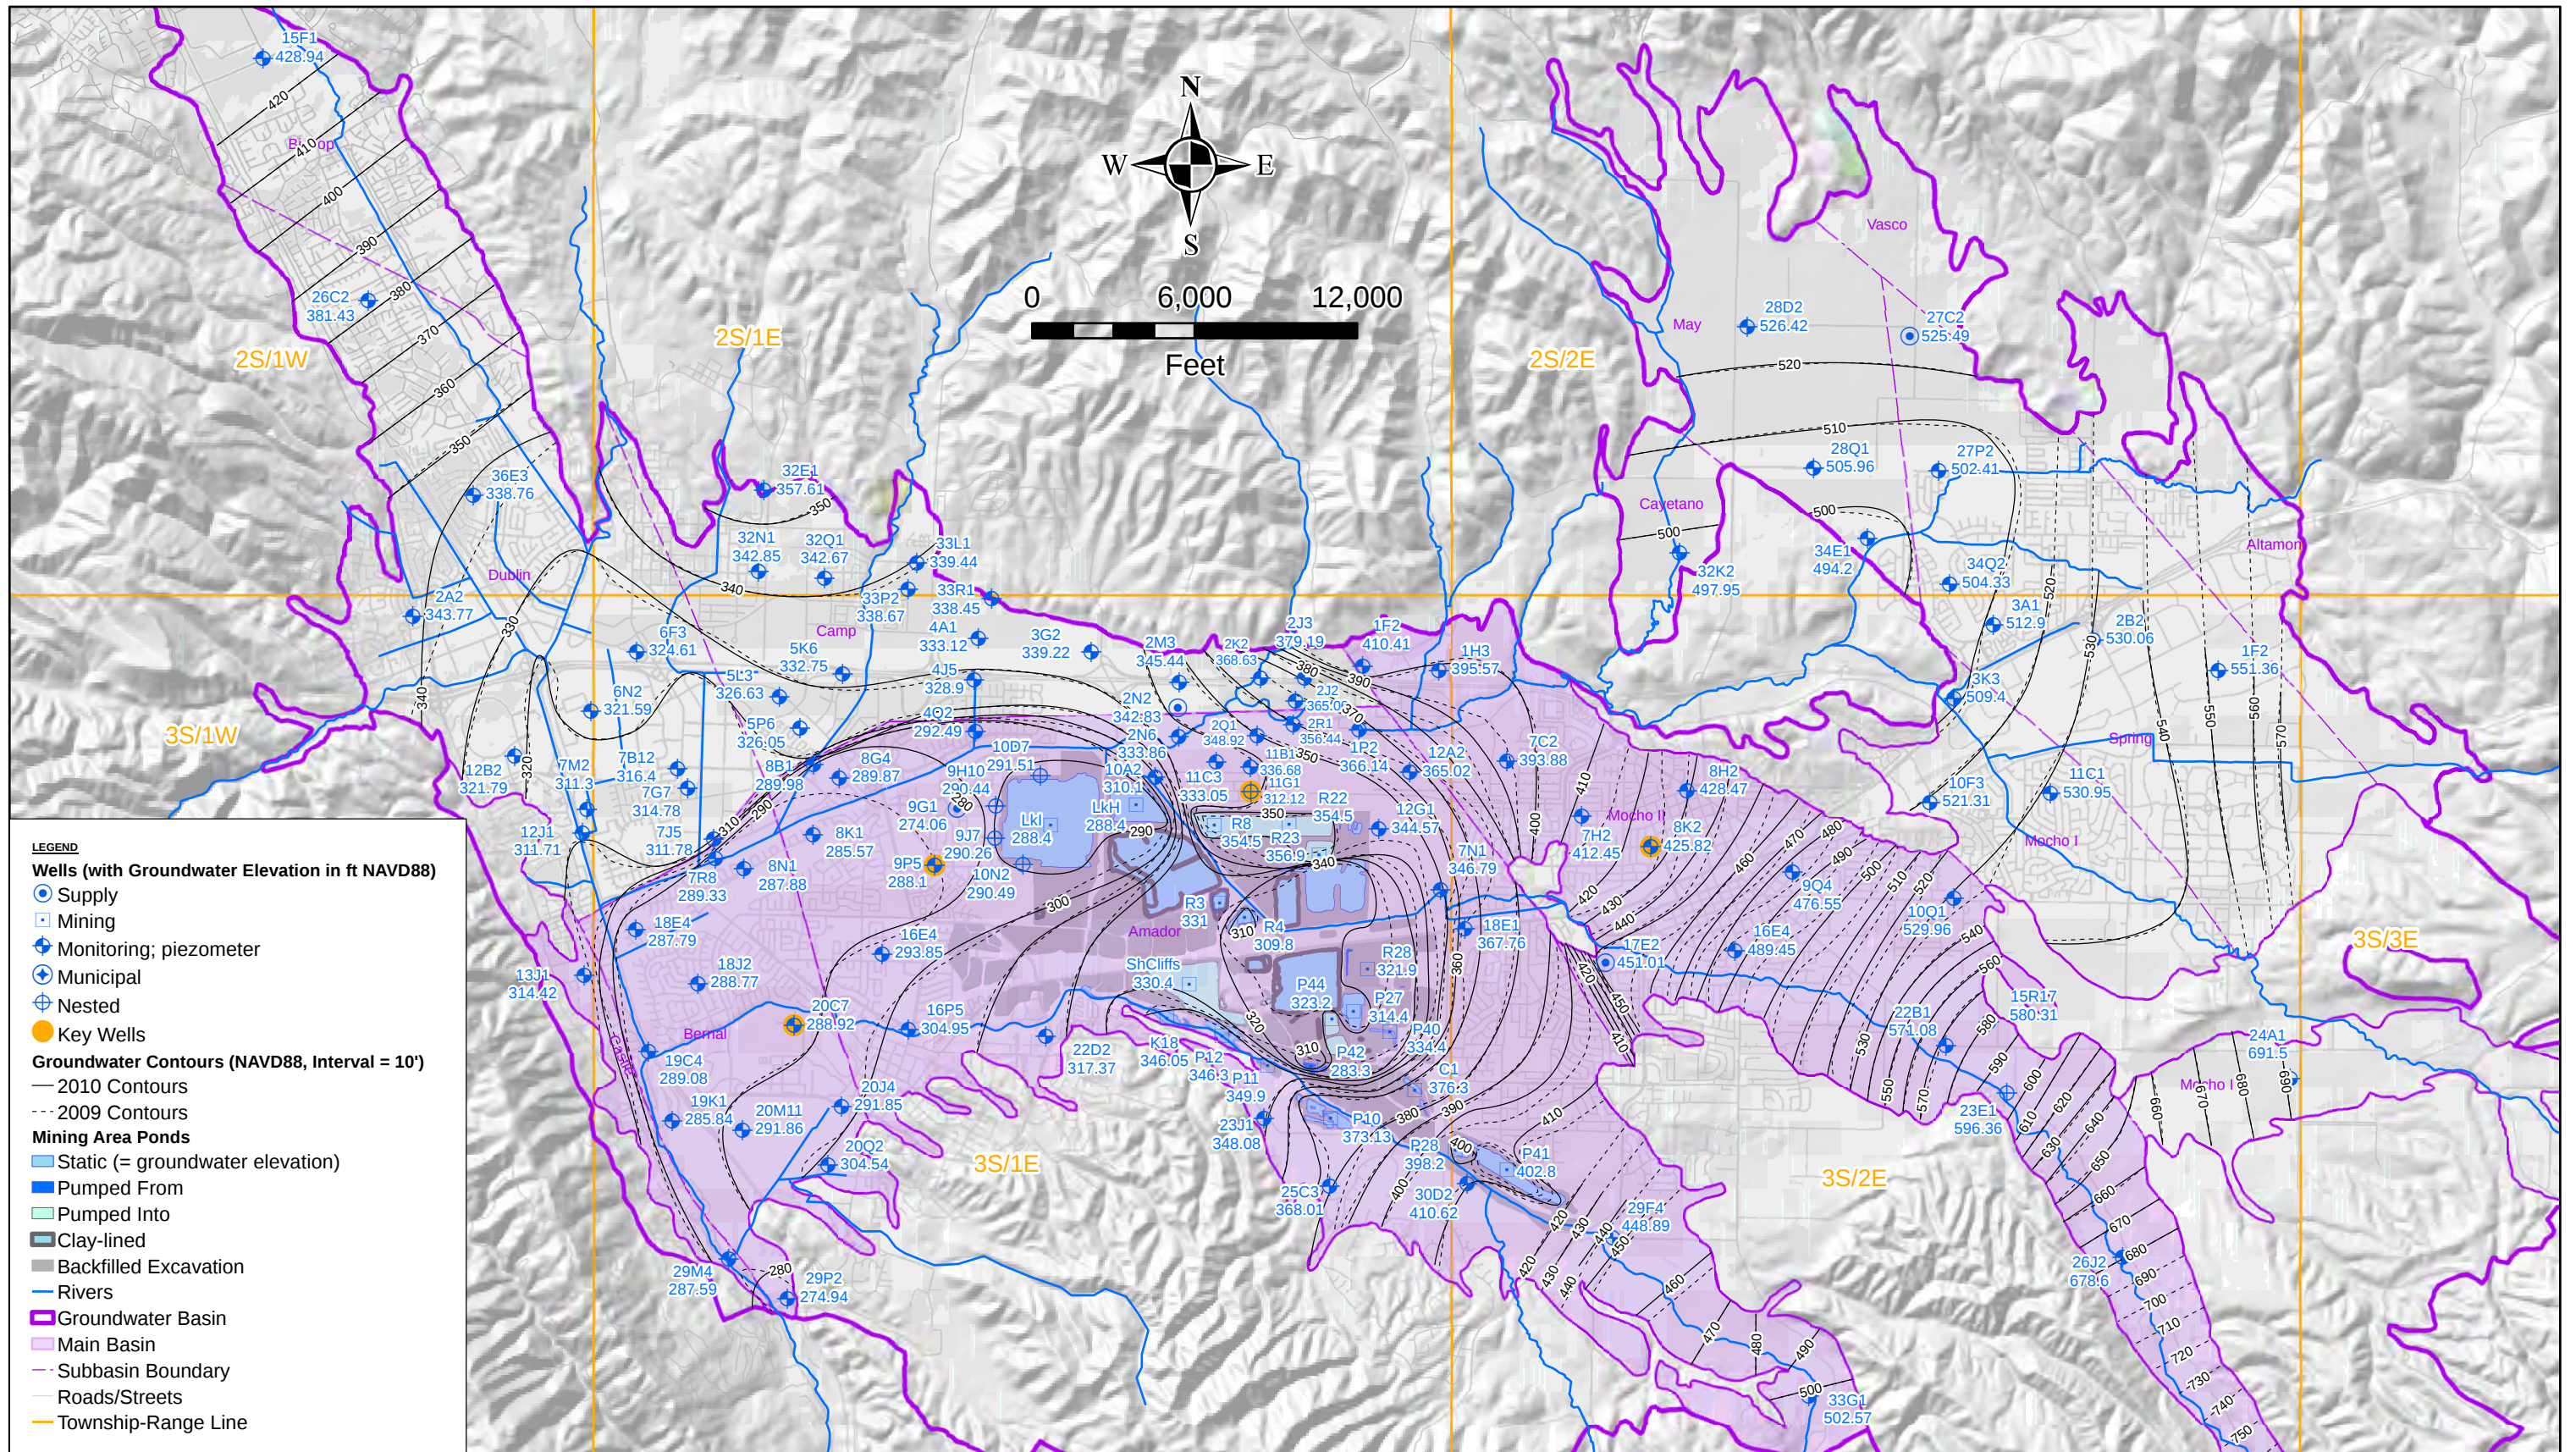
**Figure 3.2-5**  
**Groundwater Gradient Map**  
**Upper Aquifer; Fall 2010 (September)**  
**Livermore Valley Groundwater Basin**
